YEAR
1991 - 93

MODEL
LEGEND

BULLETIN NO.
93-006

Cold Engine Knock

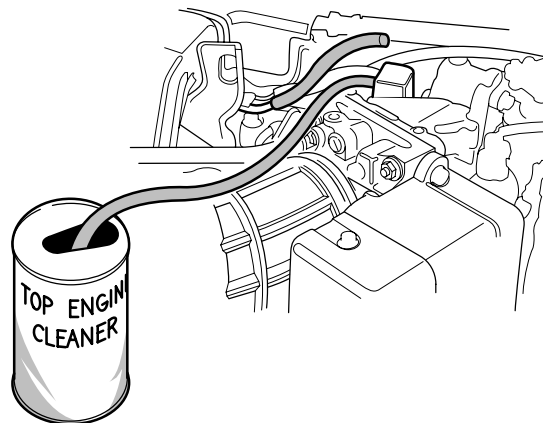
1. Disconnect the No. 21 hose at the base of the throttle body.
2. Connect a long hose to the throttle body base.

3. Start the engine. Keep it running at 800-1,000 rpm, then place the hose in the Top Engine Cleaner. Run the engine until the can is empty, then immediately shut it off.
