YEAR
1992

MODEL
INTEGRA
LEGEND

BULLETIN NO.
92-004

Product Update: Oil Pressure Switch

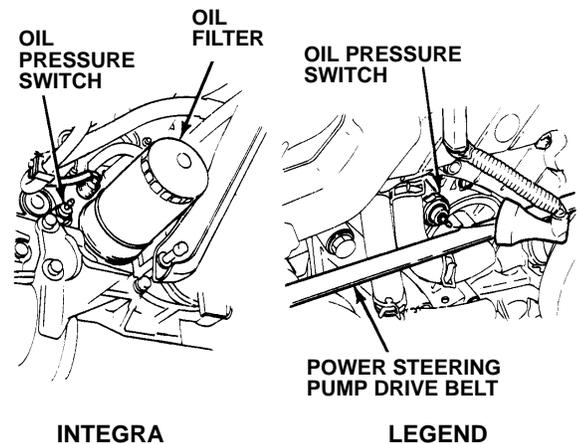
Oil pressure switches are supplied to Acura by two companies. A quantity of switches supplied by one company late in 1991 have a manufacturing defect that can cause them to seep oil at the joint between the plastic cap and the metal case.

2. Locate the oil pressure switch. To inspect the plastic end to see what color it is, remove the wire and boot by pulling them straight off.

3. a) If the switch has a black plastic end, reconnect the wire and boot and go to step 4.
b) If the switch has a green plastic end, replace it with a new unit. Coat the threads with a 3 mm wide bead of Liquid Gasket (P/N 087180001) before installation. Torque the switch to 1.8 kgm (13 lbft).
4. Lower the hoist (Integra only). Check the engine oil level and add as needed.
5. Center punch a completion mark over the last digit in the VIN on the engine bulkhead.

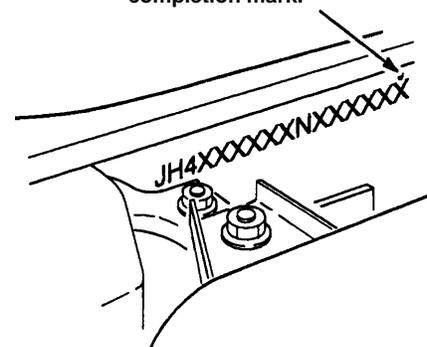
Center punch completion mark.
