MODEL  
**LEGEND**  
 4-DOOR

BULLETIN NO.  
**92-010**

## Door Mirror Vibrates

(Supersedes 92-010, dated June 8, 1992)

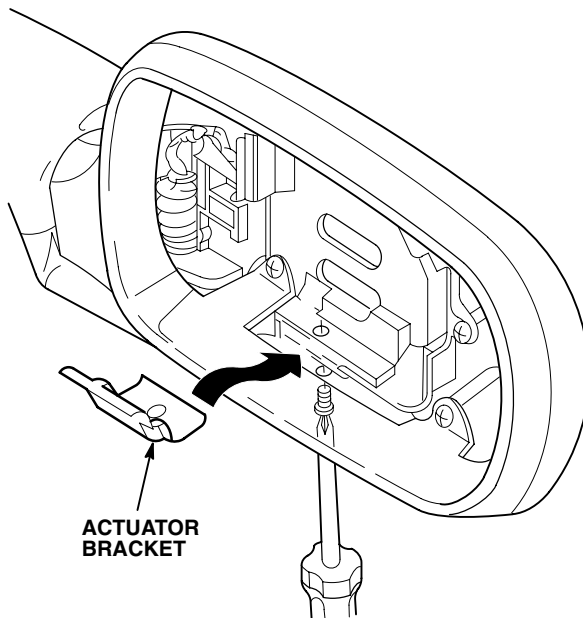
The door mirror glass vibrates due to insufficient tension of the door mirror actuator bracket.

1. Working through the service hole, use a #2 Phillips screwdriver to loosen the actuator retaining screw. (See mirror glass replacement in section 20 of the appropriate service manual.)
2. Remove the mirror and actuator assembly by lifting up, then pulling out the lower edge of the mirror.
3. Remove the 3 x 10 mm actuator retaining screw and the actuator bracket.

4. Position the new actuator bracket over the service hole.
5. Put the new screw on the screwdriver, and align the retaining bracket. Start the screw, but don't tighten it yet. Be careful to not cross-thread the screw.

6. Connect the two actuator connectors, and install the mirror assembly. Install the top edge first, then the bottom edge.
7. Tighten the retaining screw.
8. Turn the ignition switch ON, and check the mirror operation.
