PGM Tester 5.0 Software Is Here

ACURA ServiceNews

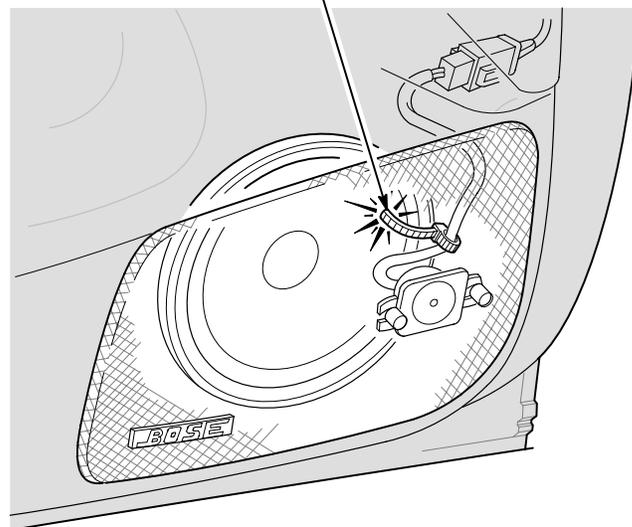
A buzzing from the door speaker on a '95 Legend may be caused by a wire harness clip contacting the speaker cone. Remove the door panel, and check the cut end of the speaker harness clip (it's a clip with a built-in wire tie). If the end of the wire tie is contacting the speaker cone, cut off the excess.

Wire tie end contacts speaker cone. (Cut off excess.)

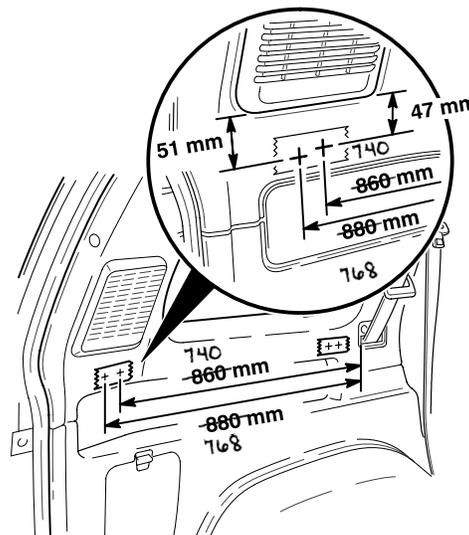
Some of the dimensions in step 4 of the '96 SLX Cargo Cover Installation Instructions are incorrect. These instructions will be revised, but in the meantime, correct your current copies.

Here's the second illustration from step 4 with the corrected dimensions.
