N&V

ACURA ServiceNews

BSN 14925 (9111)

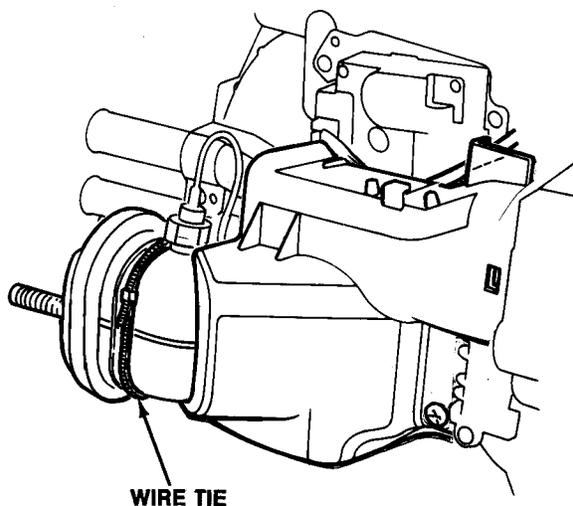
The A/C evaporator pipe cover on a Vigor can vibrate and produce a rattle at about 3,000 rpm while the car is accelerating. Even though the cover is under the dash, right above the accelerator pedal, the noise may sound like it's coming from the center vent area.

The cover is two-piece, split horizontally, with a connecting screw on the bulkhead end. We've found that a wire tie around the middle of the cover, right in front of the expansion valve, will eliminate the rattle.

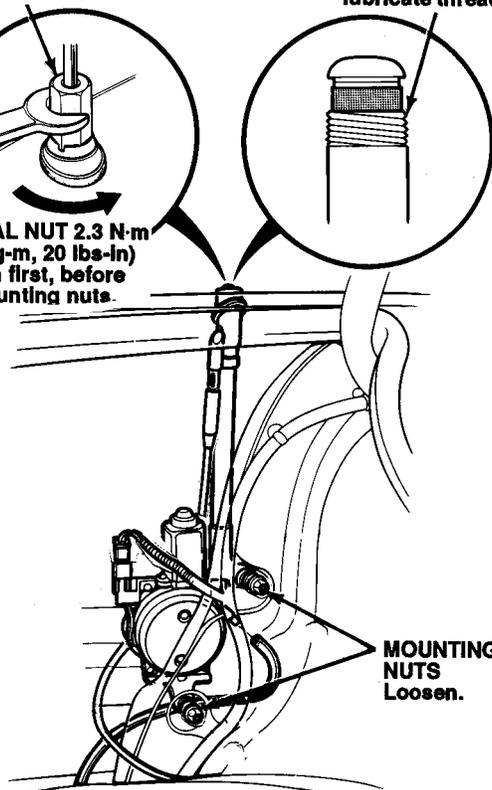
Poor AM radio reception is often caused by a poorly grounded antenna. In the October '88 issue we discussed how to fix poor grounds on roof-mounted antennas. Here's how to do the same on fender-mounted antennas:

Clean and lubricate threads.

SPECIAL NUT 2.3 N-m
(0.23 kg-m, 20 lbs-in)
Tighten first, before
the mounting nuts.

Loosen the two antenna motor mounting nuts and remove the special nut from the mast housing. Clean and lubricate the mast housing threads. Reinstall and tighten the special nut to 2.3 N-m (0.23 kg-m, 20 lb-in) *first*, then tighten the two mounting nuts.

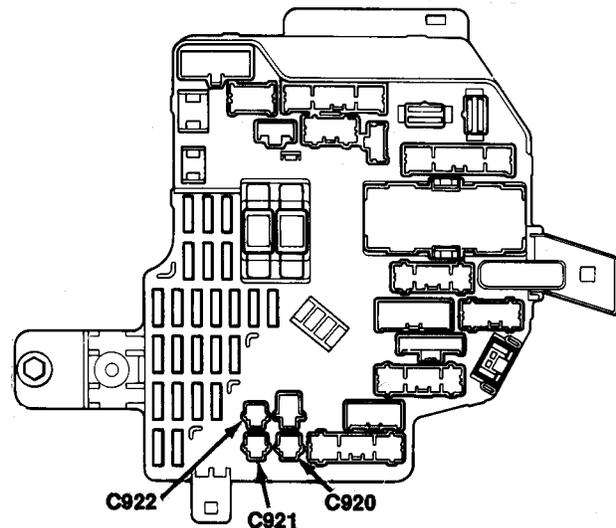
Both the L and LS have a heavy gauge WHT/BLU wire that runs from the under-hood fuse/relay box to the left kick panel area. On the LS, this wire powers the stereo amplifier. On the L, the wire stops at an unused connector tucked under the driver's footrest. If this WHT/BLU wire is mistakenly plugged into C920, C921, or C922 on the under-dash fuse/relay box, the following will occur:

WHT/BLU to C920: The blower motor is powered all the time (even with the ignition switch off).

WHT/BLU to C921: If the car has fog lights, the fog light connector (WHT wire) should be in C921. So with the WHT/BLU wire in C921 and the WHT wire disconnected, and both the fog light and high beam switches on, the high beams will stay on with the headlight switch off.

Or, with the WHT/BLU wire in C921 and the fog light WHT wire mistakenly plugged into C922, the headlights will stay on all the time.

WHT/BLU to C922: The cigarette lighter, radio, and antenna are powered all the time (even with the ignition switch off.)
