'94 Integra A/C System Won't Work

ACURA ServiceNews

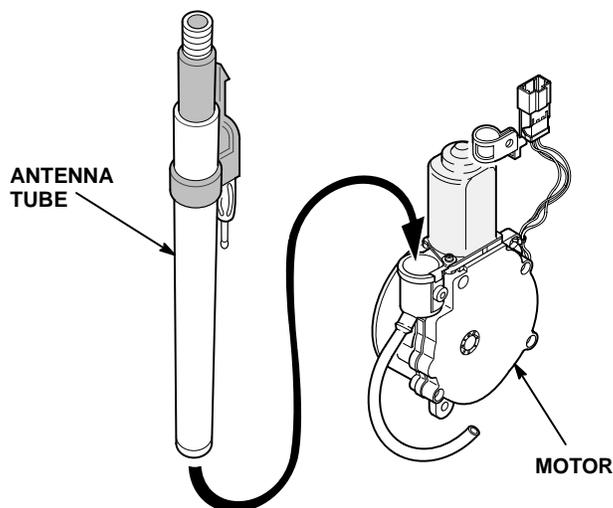
Antenna Motor & Tube Replacement

Until recently, most replacement antenna motors came with an antenna tube. Now, the motors and tubes are available separately. In fact, motors with antenna tubes will continue to be available only until current stock is depleted. For all the applications and P/Ns, refer to Parts Information Bulletin (PIB) B94-0030, "Replacement Antenna Motors Without Antenna Tubes, 1986-94 Legend, 1990-94 Integra, 1992-94 Vigor, 1991-94 NSX," filed under "New Parts."

The replacement procedures for the antenna motor or the tube are about the same regardless of what year or model car you're working on. Refer to "Antenna Tube Replacement" in either the '95 Integra S/M or the '95 Legend S/M Supplement.
