Inner CV Joint Design Change

ACURA ServiceNews

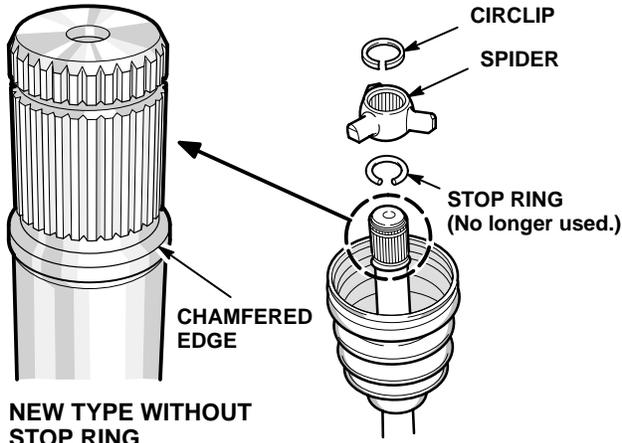
If you order replacement driveshafts and inner CV joints for an Integra or a Vigor, they'll no longer come with a stop ring for the inner CV joint. Instead of a groove, the driveshaft has a chamfered edge to prevent the spider from sliding off the splines.

To avoid reassembly problems when you replace inner CV joints on Integras or Vigors, look closely at the end of the driveshaft, and don't install a stop ring if there's a chamfered edge at the end of the splines.

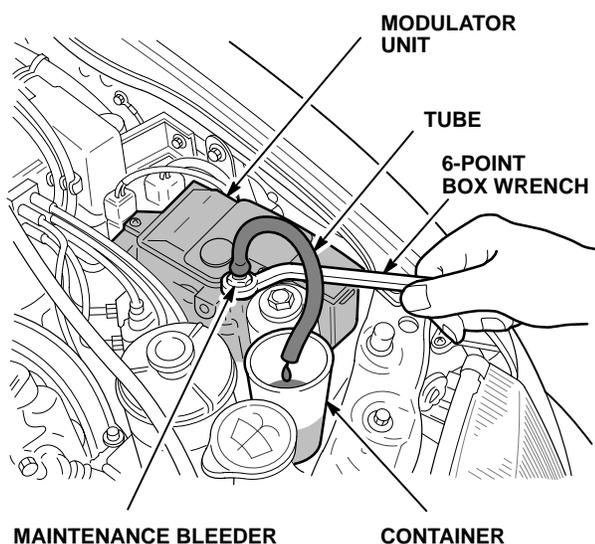
To replace the ABS modulator fluid on '94-97 Integras, '97 2.2CLs, and '97 3.0CLs, use this improved version of the S/M procedure.

1. Remove the ABS modulator reservoir cap, then remove all the fluid and sediment from the reservoir with a clean bulb syringe (turkey baster).
2. Refill the reservoir to the MAX line with Genuine Honda DOT 3 brake fluid.
3. Remove the bleeder cap from the ABS modulator bleeder, and put a 6-point box-end wrench on the bleeder bolt.

4. Push one end of an appropriate diameter hose onto the bleeder bolt (it should fit snugly), then insert the other end into a container to catch the brake fluid.
5. Wearing eye protection, bleed the fluid from the reservoir into the container by *slowly* loosening the bleeder bolt an eighth to a quarter turn. *Do not loosen the bolt more than a quarter turn. The highly pressurized fluid can whip the hose around or even blow it off the bleeder bolt.*
6. Tighten the bleeder bolt, then remove the hose, the wrench, and the container.
7. Start the engine, let it run for a minute, then shut it off.
8. Repeat steps 3 thru 7 until the fluid in the reservoir reaches the MIN line. *Do not allow the ABS pump to run when the fluid is below the MIN line.*
9. Tighten the bleeder bolt to 11 NVm (8 lb-ft), then reinstall the bleeder cap.

10. Refill the reservoir to the MAX line with Genuine Honda DOT 3 brake fluid.
11. Start the engine, and make sure the ABS indicator goes off.

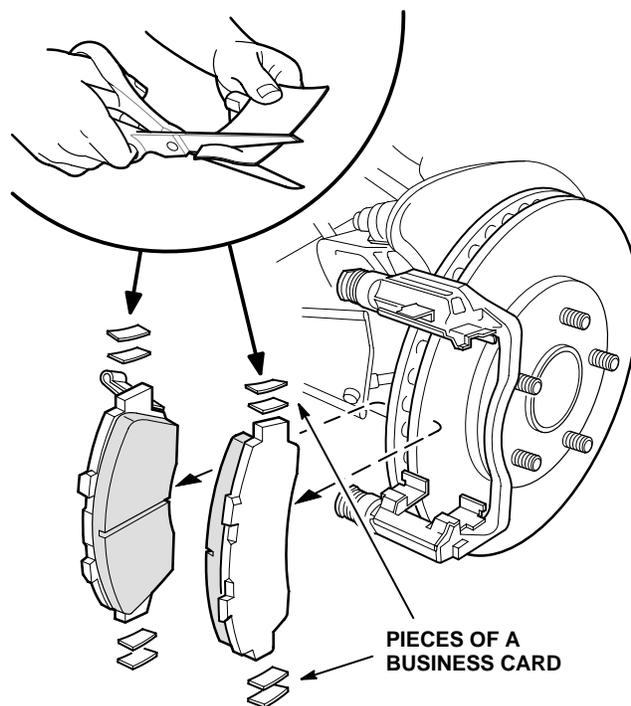
On any Acura, clearance between brake caliper brackets and the ends of the brake pad backing plates can cause a clicking noise the first time you apply the brakes in a new direction of travel (such as when you back up and then drive forward and apply the brakes). *This is a normal characteristic of the brake system.*

If you *really* need to convince a customer that the noise is normal, remove the pads from the caliper brackets and shim the ends of the pad backing plates with cut-up pieces of a business card until you can reinstall the pads snugly. If the noise temporarily goes away, you've confirmed that it was caused by the pads contacting the caliper brackets.

Don't worry about removing the card material. It'll get pulverized and fall out by itself after a short time.
