**ACURA** ServiceNews

BSN 16110 (9309)

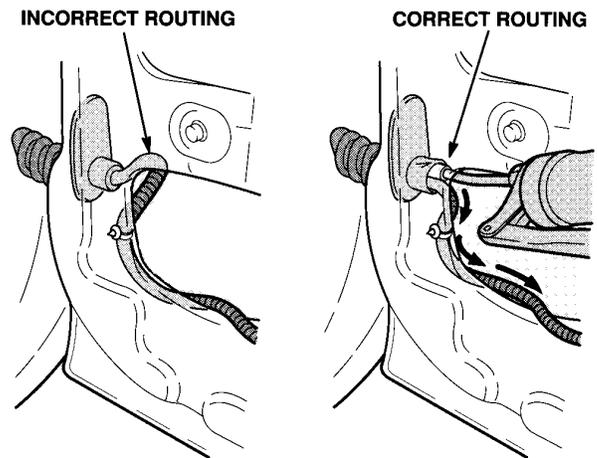
**Legend Rear Power Window Won't Work**

Corrosion, caused by moisture, in the rear door harness connector may cause a rear door window on a 1991-93 Legend to quit working.

To prevent the problem from recurring, remove the rear door panel. Look at the corrugated rear door harness protector where it goes into the rubber boot at the front of the door. You'll probably find that it enters the boot at a downward angle, which allows water to run down the wires to the connector. If so, release the harness from the first clip that holds it to the door. Pull the harness down (about 2") so that it enters the boot at an upward angle, then secure it with the clip. Pack the boot with dielectric grease where the corrugated protector enters, then reinstall the door panel.

Remove the center pillar lower trim, the seat belt retractor, and the plastic retractor cover from the appropriate side of the car, and inspect the rear door harness connector (C405 on the right side, C266 on the left side). If the connector is corroded, you've found the culprit. (Otherwise, keep on troubleshooting.) Clean the connector, and pack it with dielectric grease.

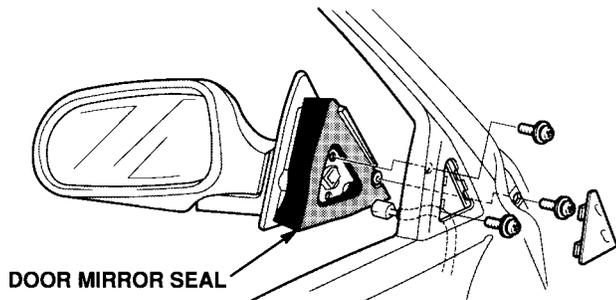
## Legend Sedan Door Mirror Seals

The urethane seals for the door mirrors on 1991-93 Legend Sedans are now available separately. (Previously, you had to replace the whole mirror if the seal was deformed or torn.) The part numbers are as follows:

Door Mirror Seal: . Left: P/N 76285-SP0-A01  
Right: P/N 76235-SP0-A01

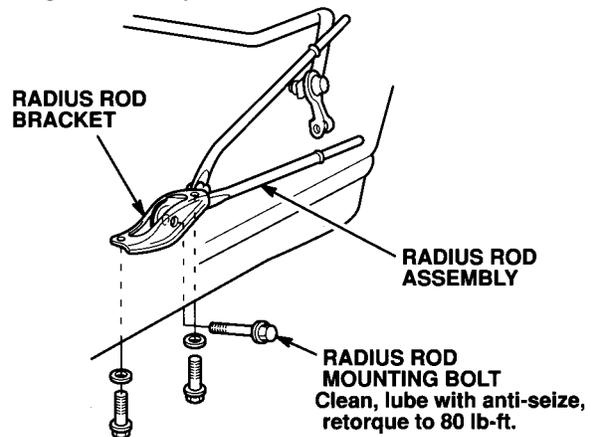
## Legend Rear Suspension "Cracks"

A loud "cracking" noise from the rear suspension of a 1991-93 Legend when driving over sharp-edged bumps or holes may occur if the radius rod bushing isn't clamped tightly in its bracket. To increase the clamping force of the radius rod mounting bolt, first remove the two radius rod bracket mounting bolts, then remove the radius rod mounting bolt. Clean the mounting bolt threads thoroughly, lubricate them with anti-seize, then torque the mounting bolt to 80 lb-ft during reassembly.
