ECU Connector Terminals Removal

ACURA ServiceNews

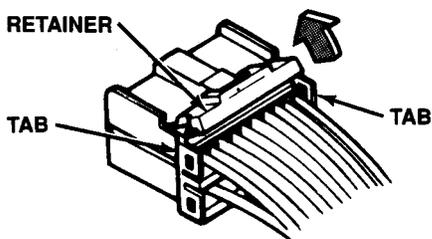
- The connectors have a retainer that keeps the terminals from sliding out the back of the housing. Carefully release the tab on each side of the retainer, then swing the retainer out of the way.

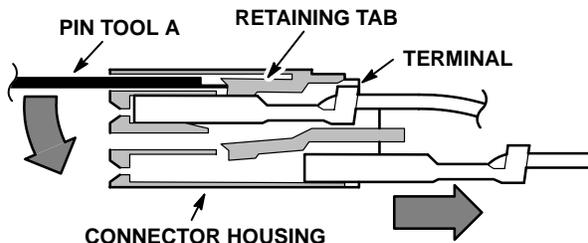
- With its long side down, insert Pin Tool A (T/N 07JAZ-002010A, from the Automobile Terminal Repair Kit, 07JAZ-003000A) into the hole above the terminal. (Pin Tool F, T/N 07JAZ-002060A, will also work in a pinch.) When you feel it stop against the terminal retaining tab, gently pry upward, then pull the terminal out the back of the housing.

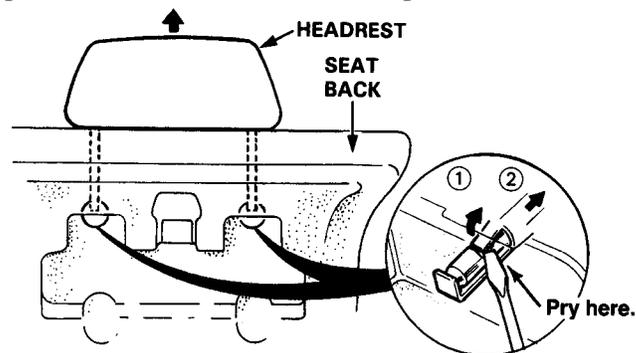
Vigor rear headrests are neither adjustable nor easily removed. A spring clip welded into each headrest guide locks the headrest support in place and keeps it from rattling around. To remove the headrests, first remove the seat back, then pry the clips away from the notch in the headrest supports and slide the headrest up. If a customer forcefully removes a headrest, the clips will be damaged to the point that the seat back must be replaced.

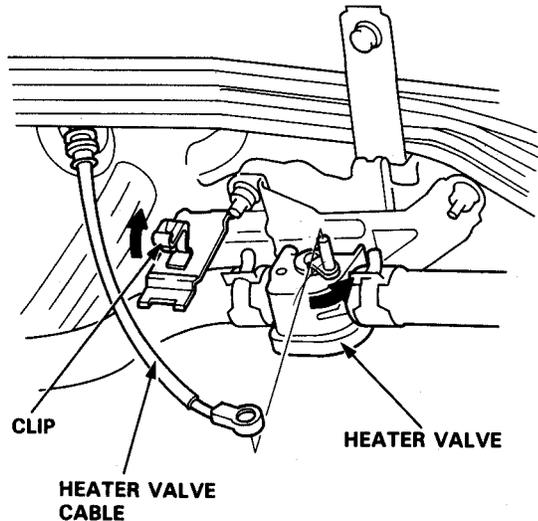
Poor A/C performance on a '91 Legend may be caused by a misadjusted heater valve cable (i.e., the heater valve is still partially open). Here's how to inspect and readjust it:

1. Remove the heater valve cable at the valve.

2. Turn the ignition switch on, then turn the temperature knob to the full cold position.
3. Push the heater valve lever to the fully closed position, hold it there, then reconnect the heater valve cable.
4. Turn the temperature knob back and forth a couple of times, then back to the full cold position. If the cable is adjusted properly, it will hold the heater valve fully closed.
