R-12: No Substitutions, Please

ACURA ServiceNews

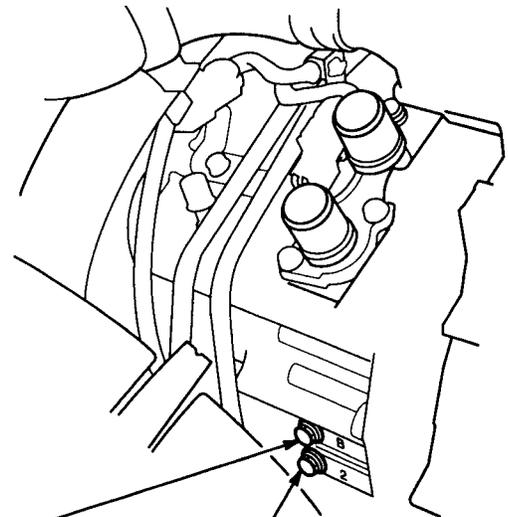
The throttle B pressure inspection hole and the 2nd clutch pressure inspection hole are incorrectly labeled on pages 14-95, 14-97, and 14-98 of the '94 Integra S/M. (The upper hole is throttle B pressure and the lower hole is 2nd clutch pressure, not the other way around.) Our thanks to **Jeff Stuck** of Crown Acura and **Jeff Leith** of Miami Acura for getting together and sending us this correction.

Here are the correct pressure hole locations and, if you're ever in doubt, look for the "B" and the "2" cast into the case adjacent to the holes.

THROTTLE B PRESSURE INSPECTION HOLE

2ND CLUTCH PRESSURE INSPECTION HOLE

And while you're on page 14-98, you'll find another error in the throttle B pressure table at the bottom of the page. The two pressure checks in the lower right corner of the table should be made with the "throttle control lever fully *open*" (not fully closed).

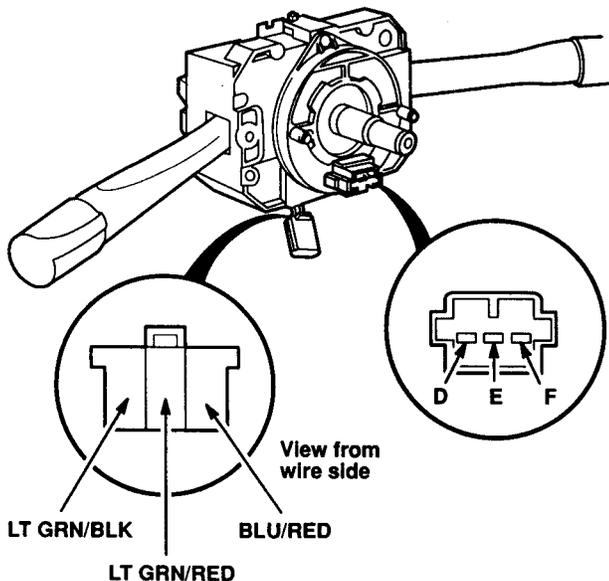
One of the wire colors is wrong in the slip ring test in the '90-93 Integra S/Ms. Step 3 should read:

3. There should be continuity between the BLU/RED and D terminals, and the **LT GRN/BLK** and E terminals, as you turn the slip ring.

If you look at the layout of the two slip ring connectors, you can easily understand the mistake. It seems logical to go from one center terminal to the other, but that's not the way the circuit goes! Make this correction on these pages:

Integra S/M	Page
'90	23-205
'91	23-221
'92	23-229
'93	23-231
