**ACURA** ServiceNews

BSN 19426 (9801)

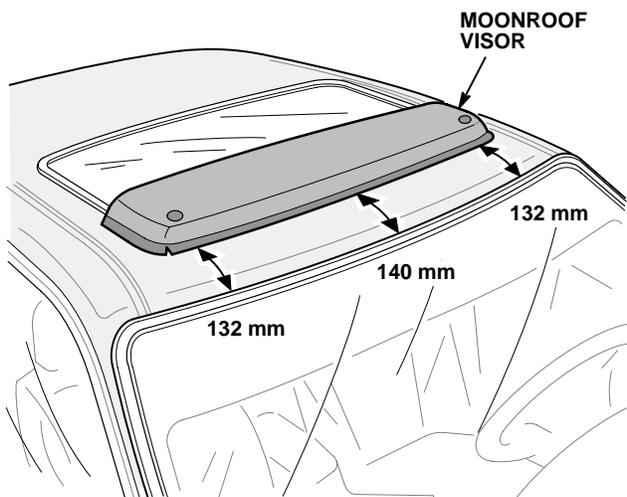
## TL Moonroof Visor “Whistles”

A whistling noise on a TL with a moonroof visor may be caused by the visor being too close to the windshield. To fix it, loosen the visor mounting screws, move the visor back until it's at the correct distance from the top of the windshield (see the illustration), then retighten the screws.

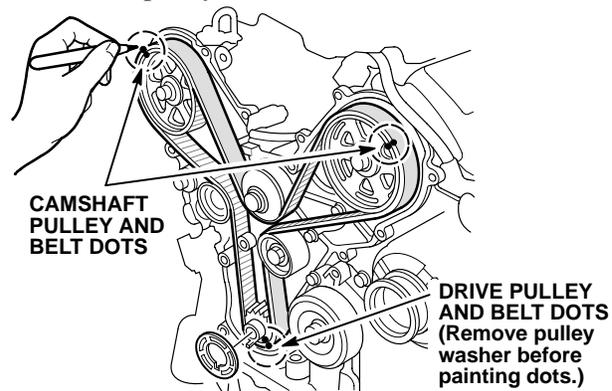
- With the camshafts correctly timed and the old timing belt still installed, paint a dot of white correction fluid on the camshaft pulleys and the drive pulley, then paint a dot on the old belt next to each of the pulley dots.

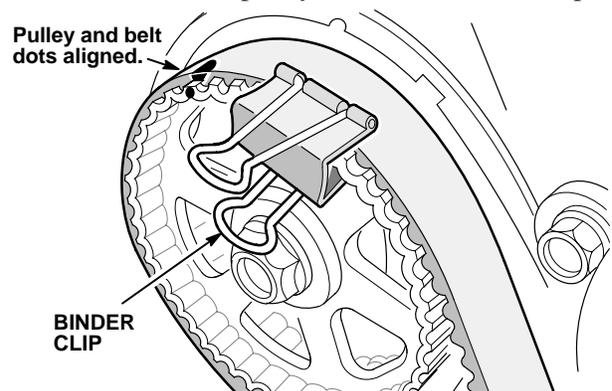
- After you remove the old belt, line it up with the new belt, and count the number of teeth between the dots. Paint dots on the new belt in the exact locations as the old one.
- When you install the new belt, line up the belt dots with the pulley dots.
- To keep the belt teeth engaged during installation, hold the belt on the pulleys with small binder clips.
