'91 Legend PDI Tips

ACURA ServiceNews

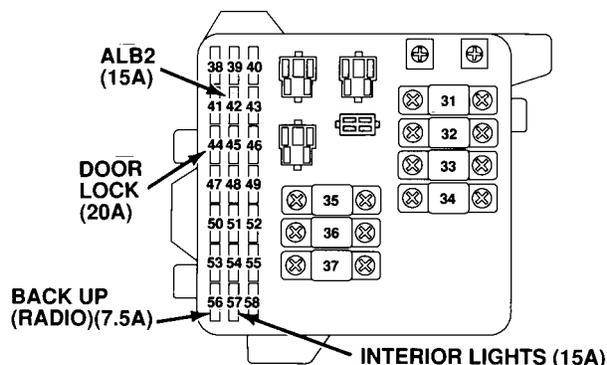
Fuses: The '91 Legend Sedan is shipped with the ALB 2, Back Up (radio), Door Lock, and Interior Light fuses removed from the under-hood fuse/relay box and stored in the ashtray. Reinstall these fuses in the positions shown below. (These positions are also designated by a bold outline on the fuse box label.)
