ACURA ServiceNews

BSN 21245 (9911)

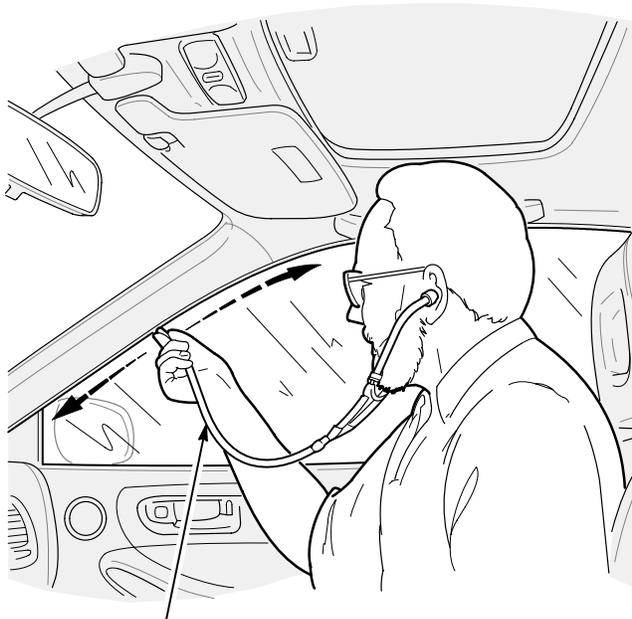
A mechanic's stethoscope is handy for finding wind noises. Just remove its probe, and, with an assistant driving the car, drag the end along the glass where it meets the run channel. Listen for differences in the noise level all the way around the glass, and fix the areas where the noise is really loud. Be careful with your diagnosis, though; stethoscopes amplify all noise, making normal glass-to-run-channel noise seem abnormally loud.

STETHOSCOPE WITH THE PROBE REMOVED
Drag along the edge of the glass to find wind noises.

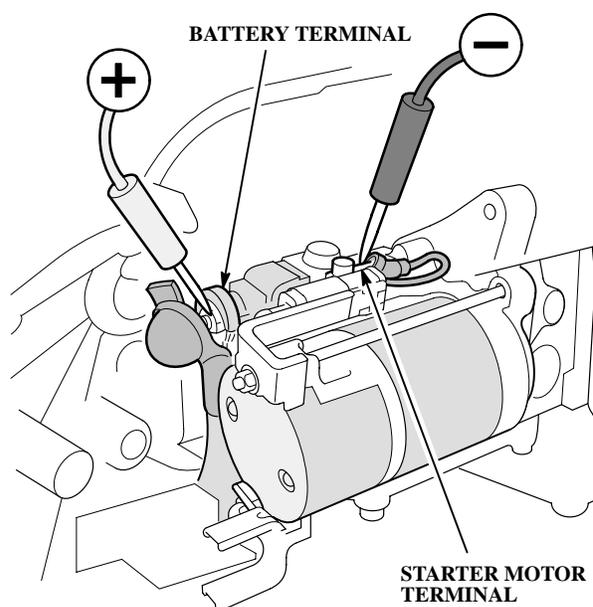
If the starter on a '96-98 3.2TL won't crank, replace it. If the starter has an intermittent no crank, do a voltage drop test on its solenoid. Here's how:

1. Set a voltmeter to the 12V DC range.
2. Attach the positive (+) voltmeter lead to the battery terminal on the starter solenoid; attach the negative (-) lead to the starter motor terminal on the solenoid.

3. Crank the starter while you read the voltmeter.
 - If the reading is more than 1V, replace the starter.
 - If the reading is less than 1V, look for loose or corroded connections between the starter and the battery.

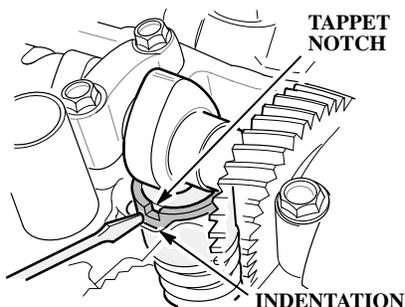
On page 6A-61 of the '98 SLX S/M, and 6A-62 of the '99 SLX S/M, the shim replacement procedure for valve adjusting is wrong. If you replace the shims according to the S/Ms, you can damage the valve adjusting tool, the valve tappets, or even the cylinder head. Cross out the shim replacement procedure in both S/Ms, and write in this note: *See the November '99 S/N or Service Training Module EN-28 for the valve shim replacement procedure.*

1. Turn the crankshaft until the nose of the cam lobe on the first valve you need to adjust is pointing away from the valve.
2. Rotate the valve tappet with a pick or a small screwdriver until the tappet notch is centered on the indentation in the head.
