Integra Front Door Glass Chatters

ACURA ServiceNews

BSN 15637 (9212)

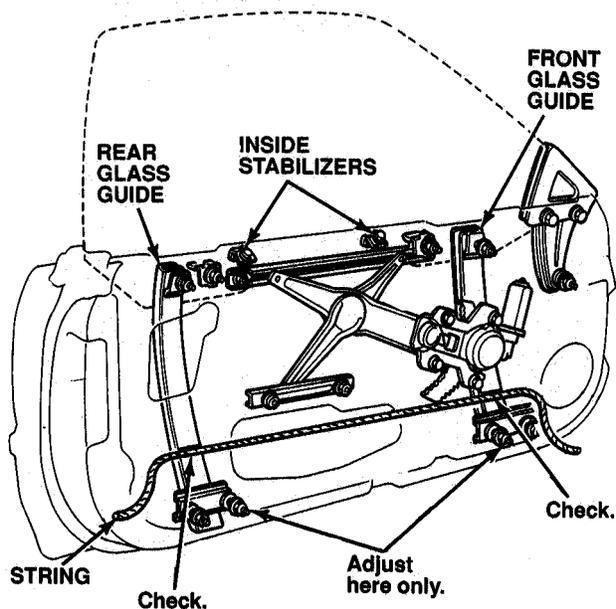
A “chatter” when the front door glass is raised and lowered on a '90-93 Integra can usually be eliminated by realigning the glass guides and regulator.

1. Remove the door panel as described in the S/M.
2. Remove the four window regulator motor mounting bolts.
3. Shim the regulator motor 2 mm away from the door skin: Insert a 2 mm thick washer between the door skin and the regulator motor at each mounting bolt location, then reinstall the mounting bolts.
4. Make sure the front and rear glass guides are parallel with each other longitudinally: Run a string from the leading edge of the front glass guide to the trailing edge of the rear glass guide. If the guides are parallel, the string will lay flat against both guides.

5. If the guides are not parallel, adjust them as necessary until the string lays flat. To avoid changing the glass camber, adjust only the *rear* adjusting bolt on the front guide, and the *front* adjusting bolt on the rear guide.
6. Once the guides are parallel, turn the adjusting bolts described above two full turns counterclockwise, then tighten the locknuts.
7. With the door glass lowered fully, make sure the inside stabilizers touch the glass lightly, then reinstall the door panel.

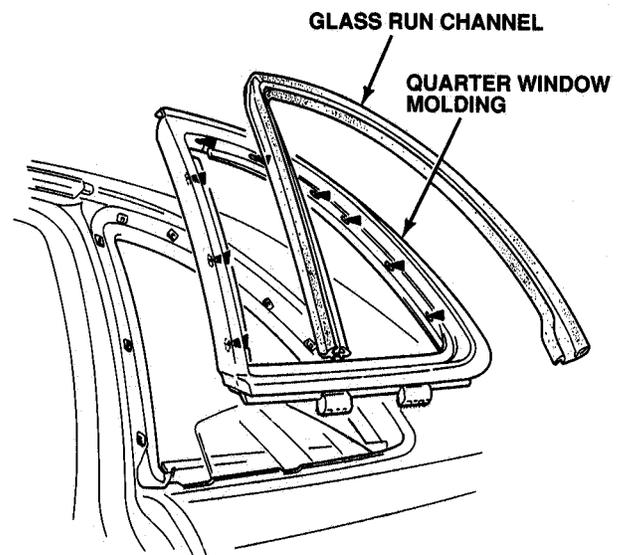
If the outer rubber trim on a '91-92 Legend Coupe quarter window molding is loose and sticking out, repair it as follows. (Replace the quarter window molding assembly only if the rubber trim is missing.)

1. Lower the quarter glass fully.
2. Peel the glass run channel out of the quarter window molding.
3. Remove the nine screws, then remove the quarter window molding.

4. Clean the quarter window molding and the outer rubber trim with adhesive remover, then reattach the trim with cyanoacrylate adhesive (“Super Glue”).
5. Reinstall the quarter window molding and the glass run channel.

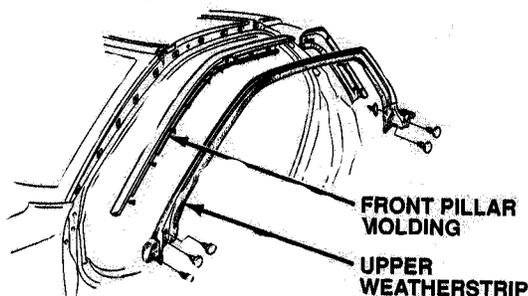
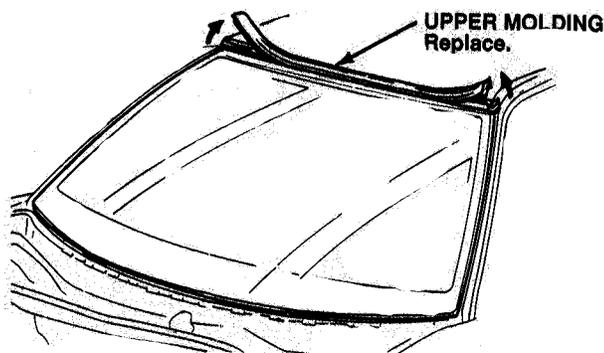
In the "Creak from NSX Windshield/Dash" article in the May '92 issue of S/N, we mentioned installing the upper windshield molding "with a dose of silicone lubricant." Since then, we've found it's best to use dishwashing soap or tire mounting lube instead of silicone. Silicone stays too slippery, and may allow the upper windshield molding to "shrink" and pull away from the front pillar moldings. Here's the easiest way to replace a shrunken molding:

1. Remove both door glass weatherstrips and front pillar moldings.

2. Using needle nose pliers, remove the small stiffener from each end of the windshield molding (between the molding and the windshield).
3. Remove the molding by pulling the ends straight up.

4. Clean any excess windshield glue from under the edge of the windshield and the upper molding fastener.
5. Remove the stiffeners from each end of the new upper windshield molding. Lube the molding with dishwashing soap or tire mounting lube, then work it into place using a 1 inch wallpaper seam roller (available from your local paint store).
6. Install the molding stiffeners, then reinstall the front pillar moldings and weatherstrips.

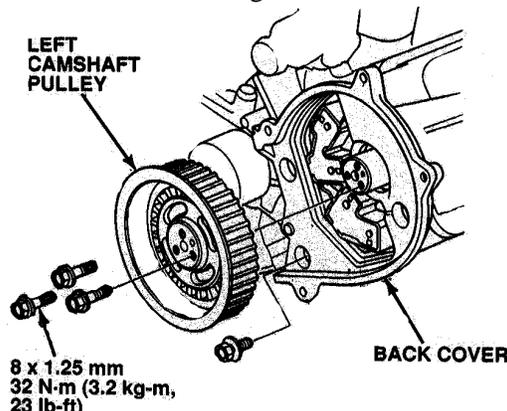
Two steps are missing from the water pump replacement procedure on page 10-9 of the '91-93 Legend S/Ms. Add these steps after step 2 (timing belt removal):

- 2a. Remove the left camshaft pulley.
- 2b. Remove the left timing belt back cover.
