ACURA ServiceNews

BSN 15879 (9308)

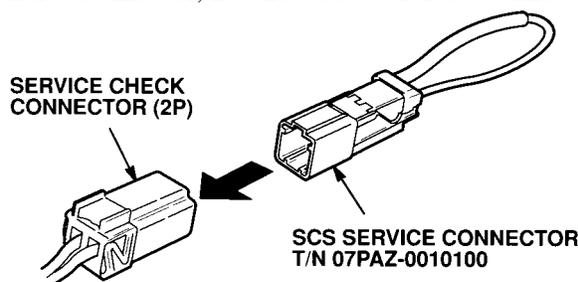
A new tool, the SCS Service Connector, T/N 07PAZ1-0010100, is now available. This simple tool (a connector half with two terminals connected by a jumper wire) makes it easier to jump the service check connector so you can read a diagnostic trouble code (DTC) on the malfunction indicator lamp (MIL). And it's cheap, too; the current dealer net price is under two bucks.

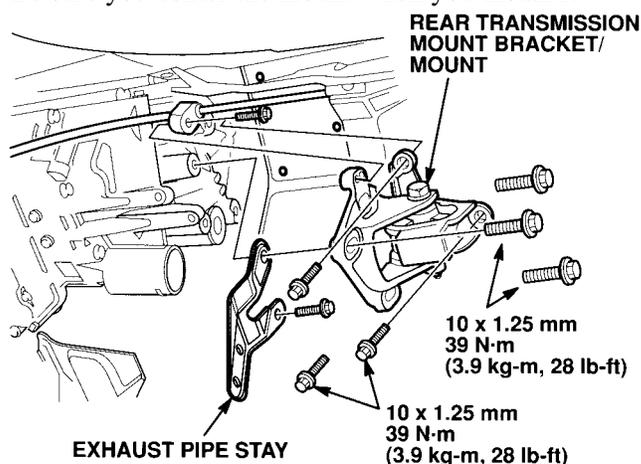
Legend Growls During Cornering

A damaged rear transmission mount cushion on a 1991-92 Legend may cause a growling or crunching noise during cornering. If the noise is coming from the floor or center tunnel area, remove the heat shield and catalytic converter so you can get to the mount. Remove the rear mount and inspect the rubber cushion. If the cushion is split, replace the mount. Be sure you center the mount when you install it.

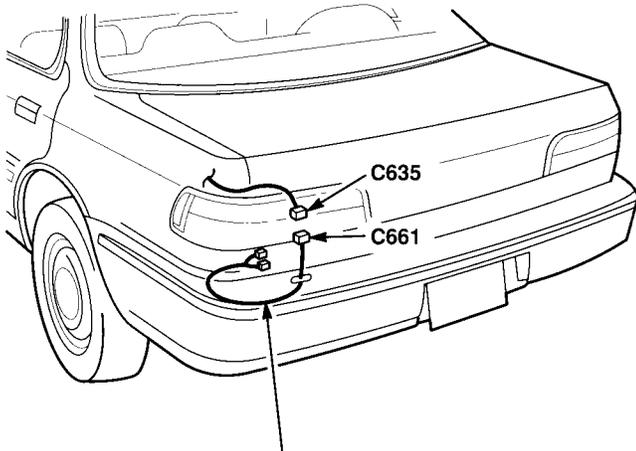
ABS REAR SPEED SENSOR SUB-HARNESS

Got a 1990-93 Integra with an ABS code 7-4? Has the car been to the body shop lately for some rear end repair? If so, head for the left rear corner of the trunk area.

Check the ABS rear speed sensor sub-harness 6-P pink connector (C661, which connects to C538 on a hatchback or C635 on a sedan). Some body shops fail to reconnect this connector properly after working in this area.
