Legend Clutch Clunks When Engaged

ACURA ServiceNews

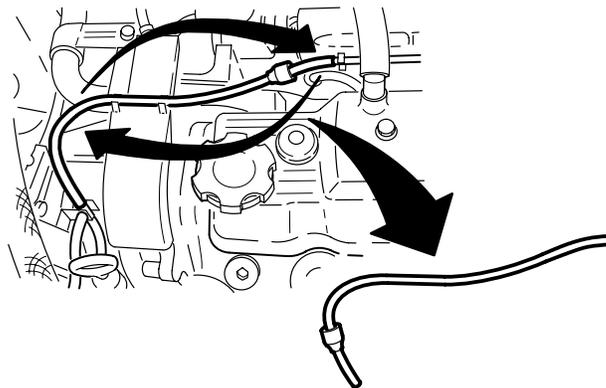
Cruise Won't Engage Below Freezing

Moisture in the cruise control vacuum check valve on an '86-90 Legend may keep the cruise control from engaging when the temperature is below freezing. If there's no apparent electrical problem (the cruise indicator light in the gauge assembly comes on), try moving the check valve from its horizontal position to a vertical position where moisture is less likely to affect it. This is easily done by switching the short hose that connects the check valve to the engine with the long hose that connects the check valve to the vacuum "T." Make sure you install the check valve in the original direction.

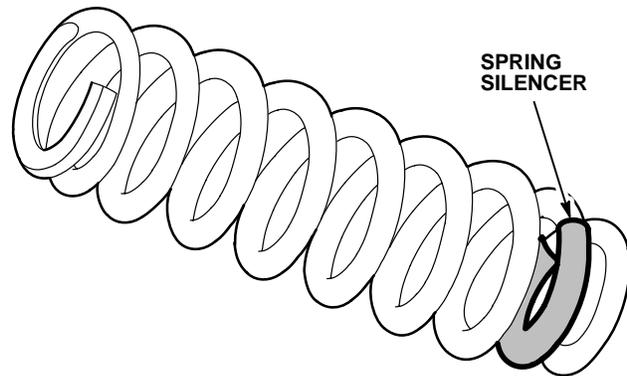
Legend Rear Suspension Noise

If the vinyl coating on '91-92 Legend rear springs wears through, the springs may make noise. The noise, a clunk or "twang," typically occurs when driving over bumps with passengers in the back seat or a load in the trunk. Raise the car and inspect the vinyl coating on the springs' lower coils. If the coating is worn through, clean the coils with solvent and dry them with compressed air, then install a spring silencer, P/N 52442-SM1-A00. Center the silencer over the worn area (usually where the second coil contacts the first coil).
