YEAR
1991 - 93

MODEL
LEGEND
4-DOOR

BULLETIN NO.
93-021

Rear Window Inoperative

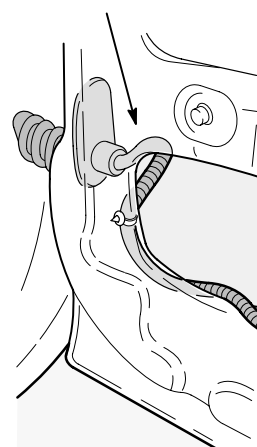
INCORRECT ROUTING

Corroded terminals in the wiring connector for the rear door.

7. Disconnect the front harness mounting clip. Reposition the harness so it enters the harness boot at an upward angle as shown.
