YEAR  
1991

MODEL  
LEGEND  
COUPE

BULLETIN NO.  
91-039

## Popping Noise from the Front Window Regulator

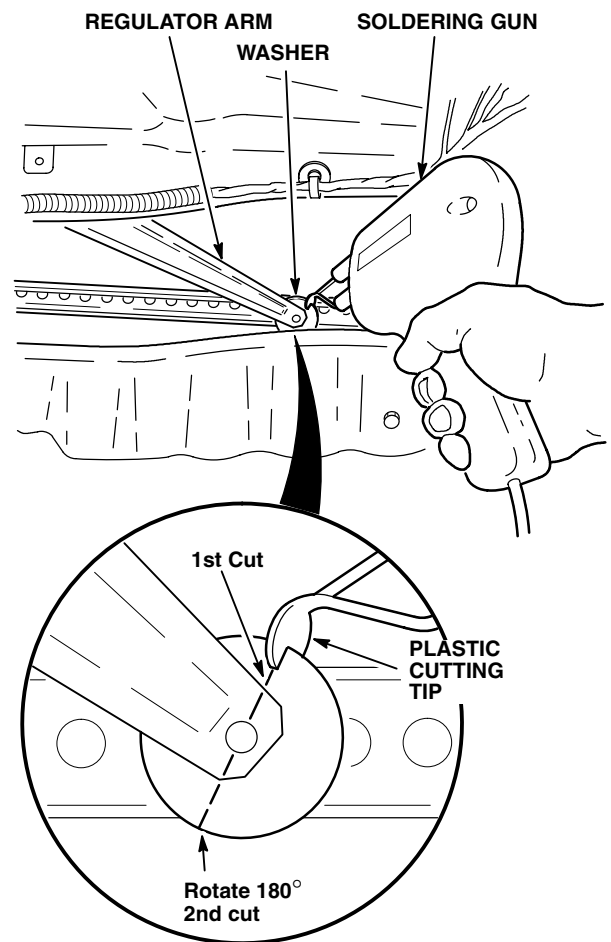
A plastic washer on the window regulator obstructs the regulator movement. When the regulator overcomes the washer's resistance it makes a popping noise.

3. Using a soldering gun with a plastic cutting tip, make a cut through the washer on the regulator arm as shown.

Use care when cutting the washer to not damage the slider with the plastic cutting tip.

4. Rotate the washer 180° and make another cut through the washer with the plastic cutting tip. Remove the washer from the regulator.
5. Lubricate the sliding surfaces of the window regulator with grease.
6. Reconnect the door panel switches and check the power window, door lock and security system for operation. Once all operations are checked, reinstall the door panel.
