## Quarter Window Molding Outer Lip Repair

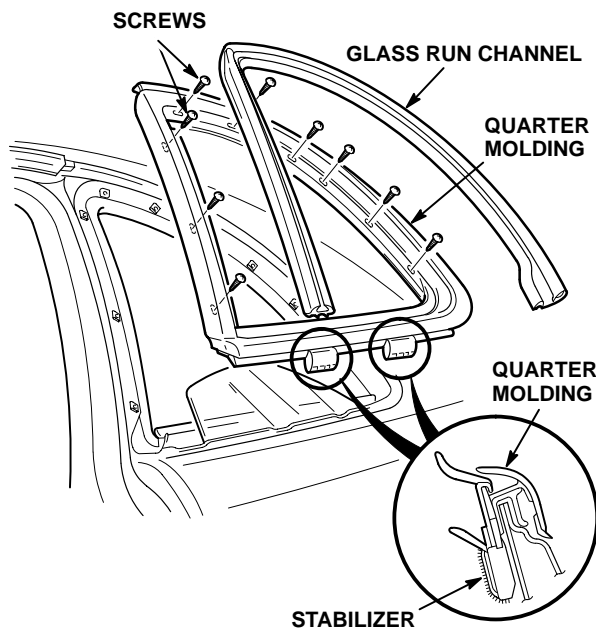
The outer lip of the quarter window molding is loose or missing.

1. Lower the glass fully.
2. Peel the glass run channel out of the quarter molding.
