YEAR  
1994

MODEL  
LEGEND

BULLETIN NO.  
95-003

## Cruise Control Will Not Engage

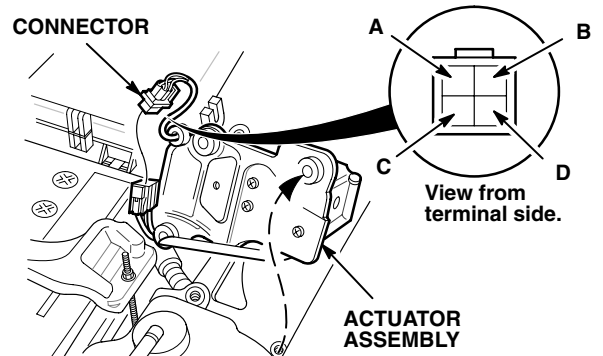
NOTE: Handle the cruise control actuator assembly carefully; excessive jarring may temporarily correct the symptom, leading to an incorrect resistance value.

3. Remove the cruise control actuator assembly (three 6 mm bolts), then roll the actuator on its side to access and disconnect the 4-P connector.

4. Measure the resistance between terminals B and C of the cruise control actuator connector.
  - If the resistance is less than 50 ohms, replace the cruise control actuator assembly (see PARTS INFORMATION).
  - If the resistance is more than 50 ohms, perform the input test in section 23 of the Service Manual. Be sure to correct the input test procedure as shown on page 2 of this service bulletin.
