Shift Problem: Trans or Control Unit?

ACURA ServiceNews

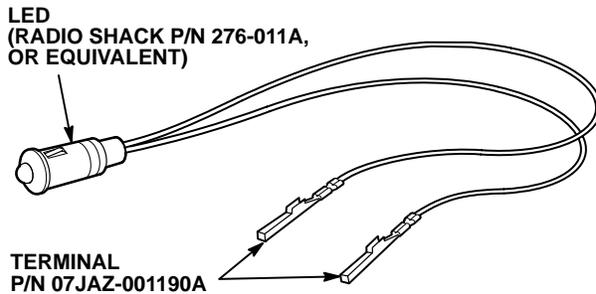
First, you need to make two 12V LED test lights. We used two Radio Shack LEDs (P/N 276-011A) with terminals (P/N 07JAZ-001190A) from our Automobile Terminal Repair Kit. Label one test light "A" and the other "B."

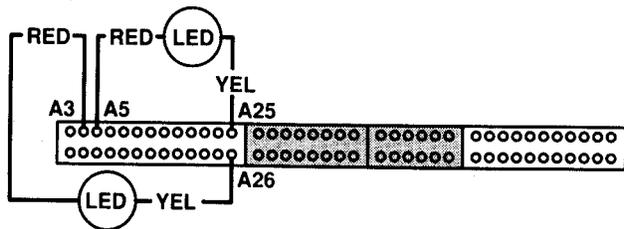
Connect your Test Harness (T/N 07LAJ-PT3010A) to the car as described in the appropriate S/M. Connect LED A to terminals A5 (+ RED) and A25 (- YEL). Connect LED B to A3 (+ RED) and A26 (- YEL).

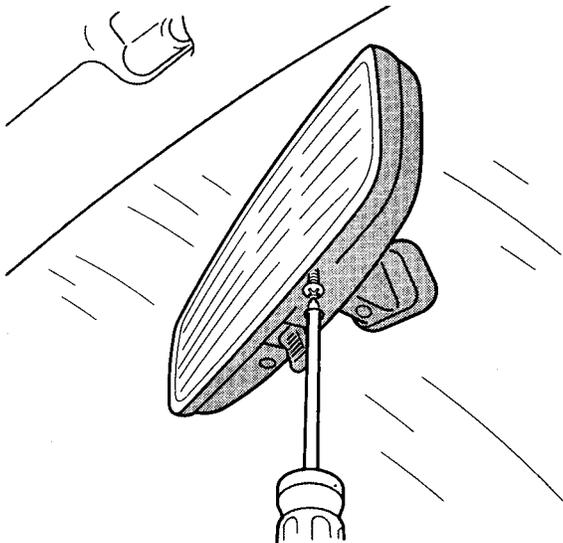
The adjustment tension is adjustable on '91-92 Legend and Vigor rearview mirrors. You can get to the adjusting screws by inserting a Phillips screwdriver through the two holes in the bottom of the mirror. Tighten the screws evenly till you reach the desired tension.
