YEAR
1991

MODEL
LEGEND

BULLETIN NO.
91-034

Power Steering Pump Noise

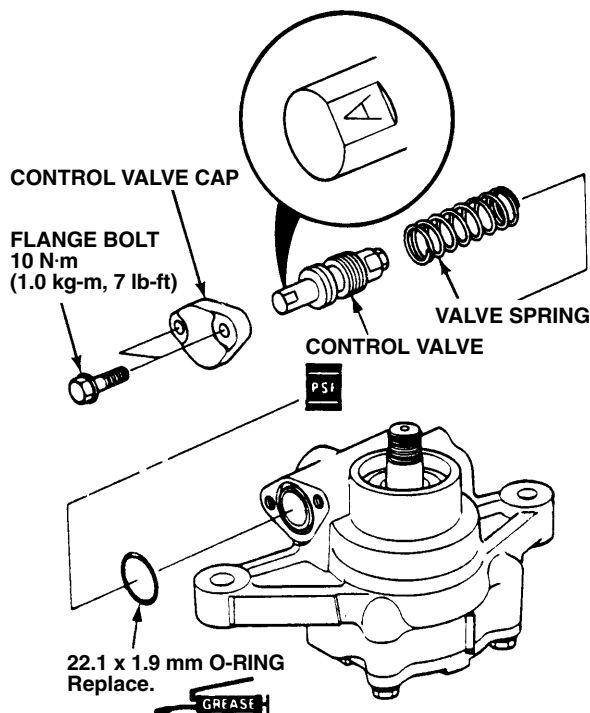
1. Remove the power steering pump as described in the service manual.
2. Remove the control valve cap and remove the control valve. Verify the control valve size by looking for the identification letter (A or B) stamped on the valve as shown.

3. Replace the original control valve with a new control valve with the same identification letter. Refer to PARTS INFORMATION.
4. Replace the O-ring and install the new control valve. Reinstall the control valve cap and torque the bolts.
5. Reinstall the power steering pump as described in the service manual.
