## Legend Interior Squeak and Rattles

### PROBABLE CAUSE AND CORRECTIVE ACTION

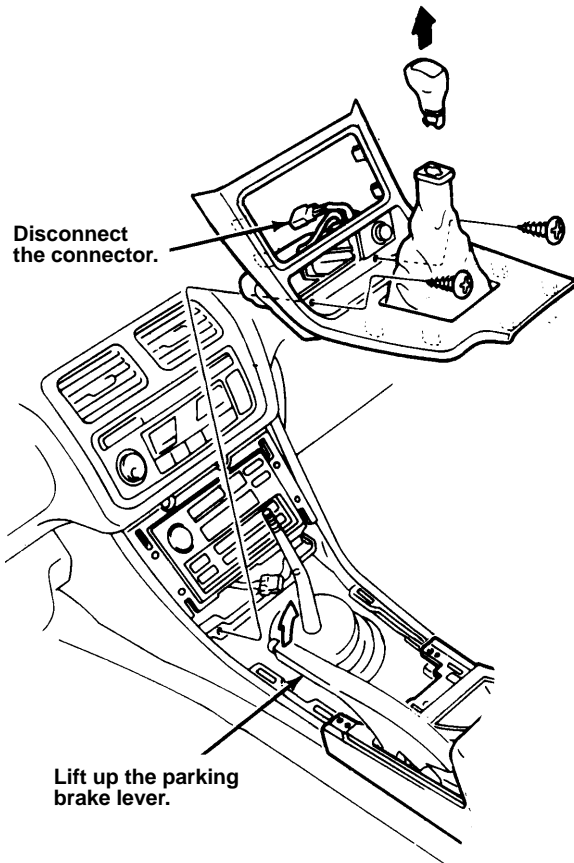
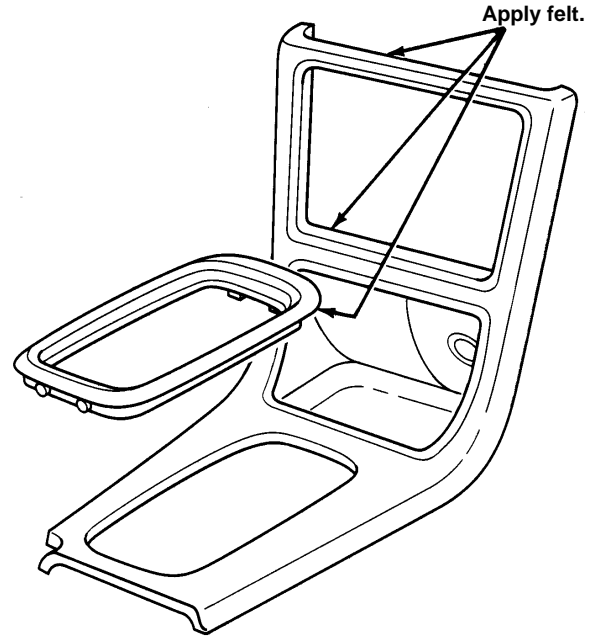
## CENTER CONSOLE

**Symptom:** Creak from the center console cover.

**Probable Cause:** The center console cover contacts the radio, the dash and the shift indicator garnish.

2. Inspect for points of contact:
  - Console cover/dash surface
  - Radio/console cover surface
  - Underside of the shift indicator garnish

**Corrective Action:** Add or re-position the felt insulation.

3. Correct insulation by re-positioning or adding felt where needed.

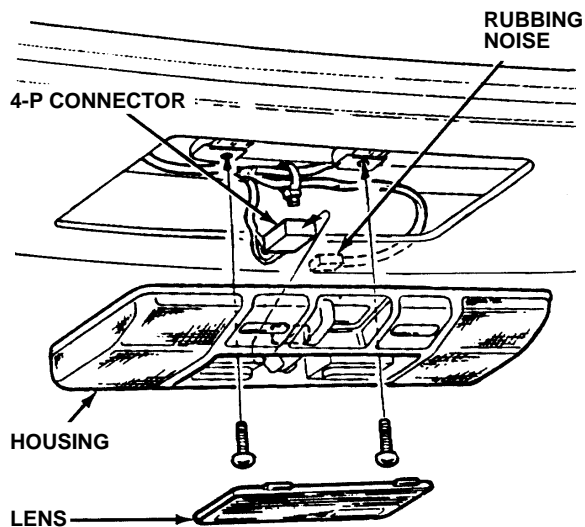
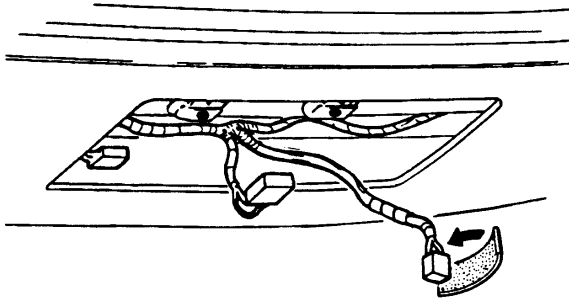
## CEILING

**Symptom:** Rubbing noise heard from the forward ceiling light.

**Probable Cause:** The 2-pin connector on the cellular phone microphone rubs against the headliner.

**Corrective Action:** Wrap the connector with EPT.

2. Wrap the 2-pin microphone connector with 3 mm thick EPT Sealer cut to 30 x 50 mm.

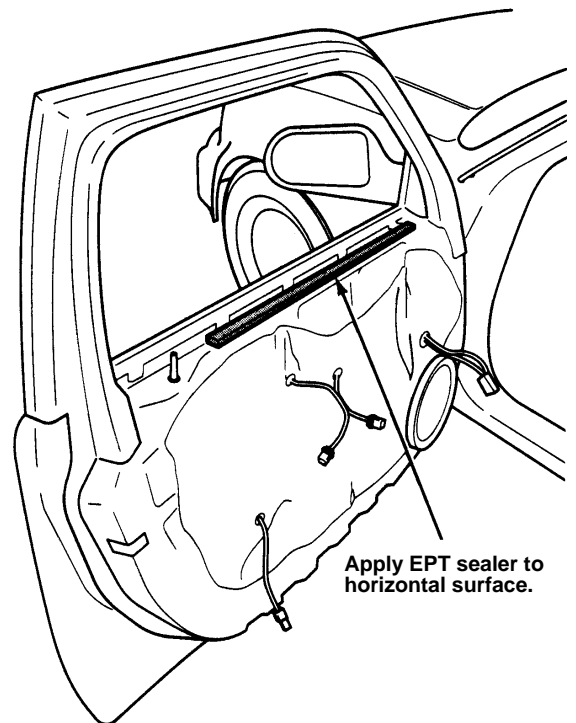
**Symptom:** Door panel creak from the inner door skin.

**Probable Cause:** The underside of the door panel rubs on the door skin when the door panel is used as an arm rest.

1. Apply a strip of 5 mm EPT Sealer to the horizontal surface of the door skin. Cover the area from the lock knob forward to the mirror triangle, as shown.
2. Reinstall the door panel.

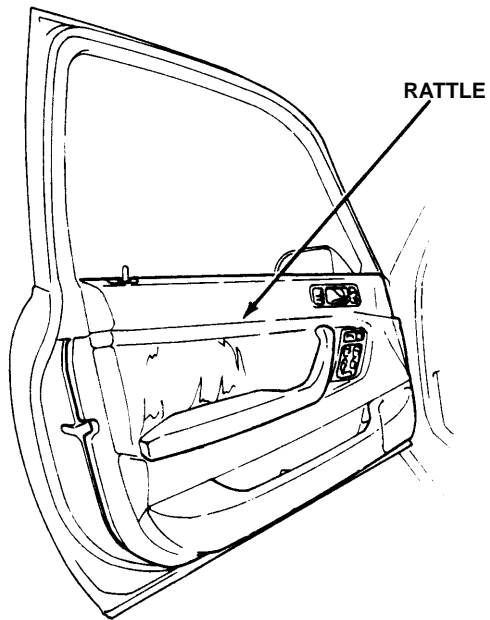
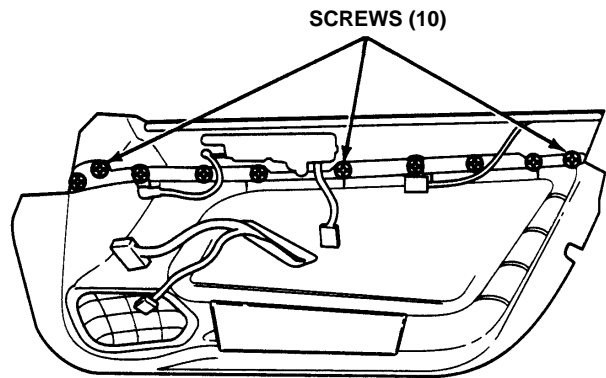
**Symptom:** Rattle from the door panel.

**Probable Cause:** The screws that attach the upper door panel to the lower door panel are loose.

**Corrective Action:** Tighten the screws.

1. Remove the door panel. See section 20 of the service manual.
2. Tighten the 10 screws that attach the upper portion of the door panel to the lower portion.

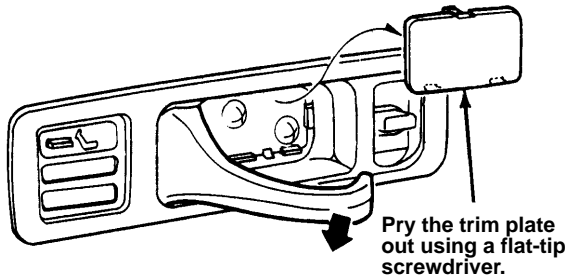
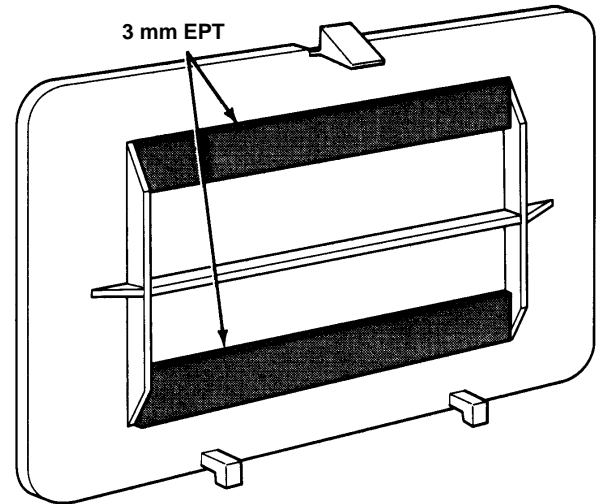
**Symptom:** Rattle from interior door handle trim plate.

**Probable Cause:** The trim plate (cap) retaining clips are loose.

**Corrective Action:** Insulate the area with 3 mm EPT Sealer.

2. Cut 3 mm EPT Sealer into a strip 10 mm wide. Apply it to the back of the trim plate. The EPT will apply pressure to the retaining clips and eliminate the rattle.

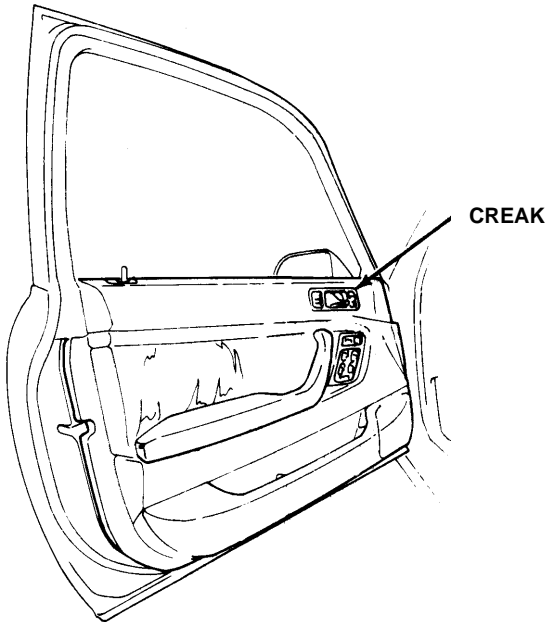
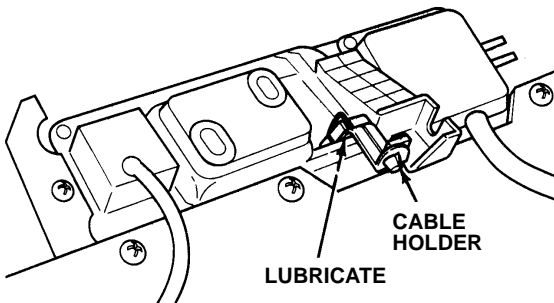
**Symptom:** Creak from the interior door handle.

**Corrective Action:** Lubricate the contact surfaces.

1. Remove the door panel, refer to section 20 of the service manual.
2. Inspect the bottom of the release cable holder for signs of contact. If the cable holder is touching the door panel, apply silicone grease to the cable holder.

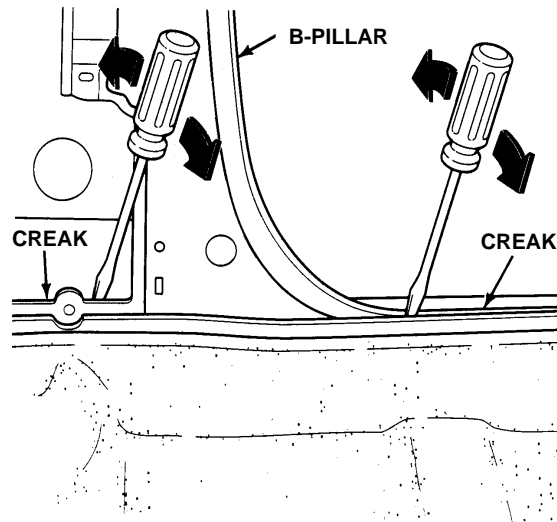
## B-PILLAR

**Symptom:** Creaking from the base of the B-pillar.

**Probable Cause:** Sheet metal friction near a spot weld.

**Corrective Action:** Spread the sheet metal to apply pressure to the spot weld.

3. Insert a flat-blade screwdriver between the layers of sheet metal next to the noisy spot welds. Spread the sheet metal slightly.
4. Raise and lower the car. If the creak is still heard, repeat step 3 until the creak is eliminated.
5. Reinstall the door sill molding and the quarter trim panel.

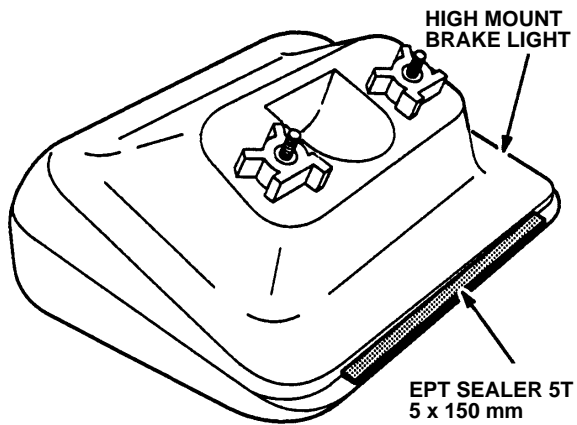
## HIGH MOUNT BRAKE LIGHT

**Symptom:** Rattle from the rear shelf.

**Probable Cause:** Clearance between the rear shelf and the brake light housing.

**Corrective Action:** Apply 5 mm EPT Sealer to the bottom of the light housing.

1. From inside the trunk, remove the bulb socket and the two mounting nuts from the high mount brake light.
2. Remove the brake light from the rear shelf and turn it upside down.
3. Cut a 5 x 150 mm piece of 5 mm EPT 5T Sealer.
4. Center and apply the EPT to the bottom of the light housing, along the rear edge, as shown.
