'91 Legend Idle Speed Adjustment

ACURA ServiceNews

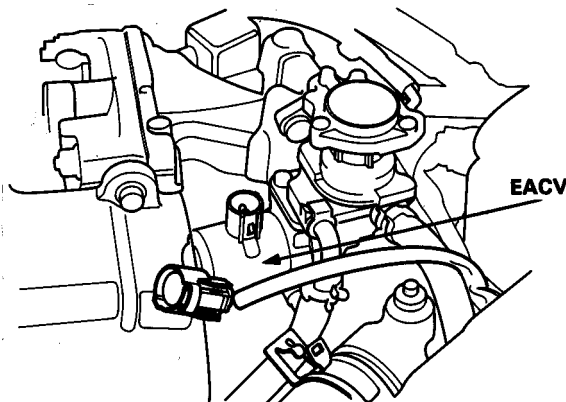
If the base idle speed on a '91 Legend is misadjusted, the engine may idle erratically, or stall. If you encounter this complaint, reset the idle as follows:

1. Warm the engine up to normal operating temperature.
2. Connect a tachometer to the loop on the igniter or to the tachometer connector.
3. Disconnect the 2-P connector from the EACV.

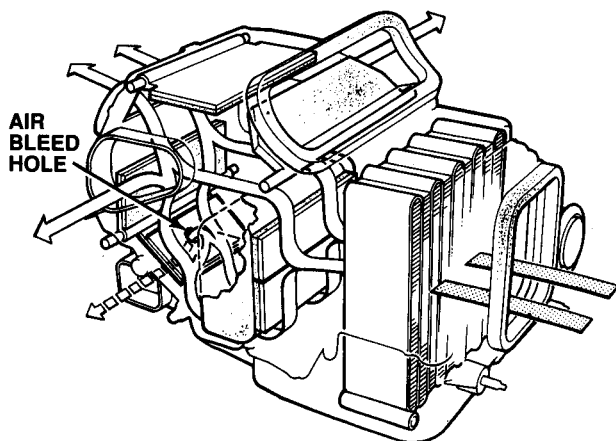
When the VENT mode is selected on an NSX, a small amount of air also flows from the foot well (heater) ducts. This feature helps cool the interior more uniformly.

If a customer dislikes this feature, a plug can be installed in the air bleed hole in the heater door. (Air will still flow from the foot well ducts in the BI-LEVEL and HEAT modes after the plug is installed.) To install the plug . . .

1. Remove the passenger's dashboard lower cover, glove box door, and glove box (see S/M, page 20-43).
2. Remove the right door glass air duct (located behind the glove box).
3. Remove the mode control motor and the white air control plate (see S/M, page 22-69). Remove the screw holding the right foot well vent, then pull the vent straight out.
4. Insert the 14 mm plug, P/N 95550-14000, through the vent, into the hole in the heat door.
5. Reinstall all the removed parts in the reverse order. Make sure all the air doors are properly adjusted (see S/M, section 22).
