YEAR  
1995

MODEL  
LEGEND  
4-DOOR

BULLETIN NO.  
94-021

## Gap in Front Door Sill Molding at B-Pillar

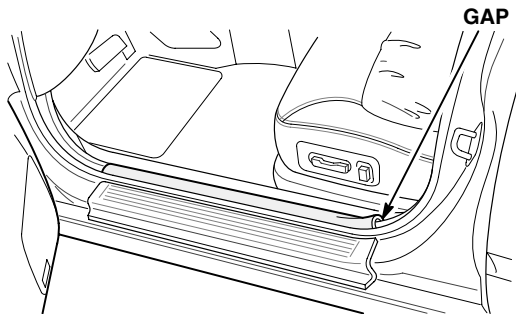
The door sill molding does not sit flush with the door opening trim at the B-pillar.

The nylon carpet retainer which holds and aligns the carpeting at the door opening is too long. The door sill molding does not provide enough clearance to fit over the door opening trim, the body seam, and the nylon carpet retainer.

Cut and remove a small section of the nylon carpet retainer to allow the door sill molding to sit flush against the door opening trim.
