Elevation Motors Need Bushings Too

ACURA ServiceNews

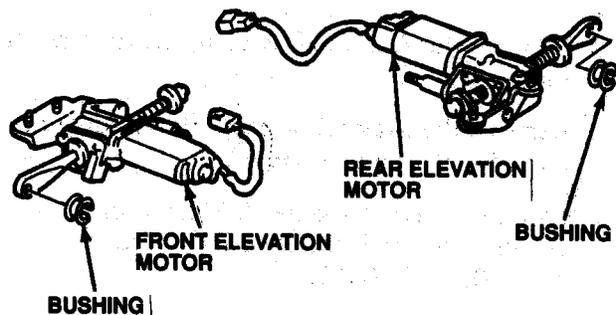
As thorough as the '91-92 Legend S/B 92-017, "Driver's Seat Rocks," is, it doesn't mention installing bushings on the front and rear elevation motor shaft ends. If you use the new link bolts from the kit without the bushings, the seat will rock more than it did before.

Luckily, the bushings are already included in the kit, and the S/B will be revised soon. In the meantime, make note on steps 11 and 20 to install the bushings before you install the new motors.

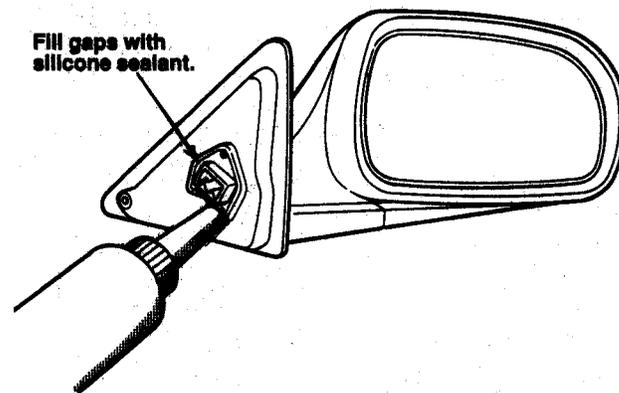
A whistling noise from the door mirror or A-pillar area of a '91-93 Legend Sedan may be caused by a poor seal around the mirror's electrical connector. Remove the mirror, fill the gap between the neoprene seal and the mirror connector with a bead of silicone sealant, then reinstall the mirror.

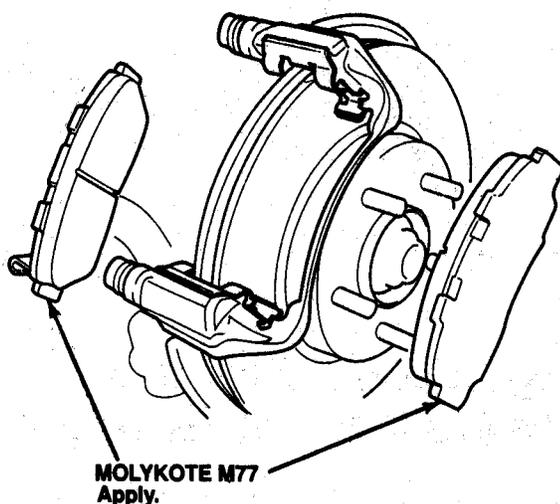
The ends of the front brake pads rubbing against the pad retainers may make a crunching or rattling noise on '91-93 Legends. The noise, which usually occurs while turning with the brakes applied, can be mistaken for other noises (worn outer CV joint, worn or loose suspension component). If you can duplicate the noise by making a sharp turn with the brakes and the throttle applied, lubricate the ends of the pads with Molykote M77.
