ACURA ServiceNews

BSN 15783 (9304)

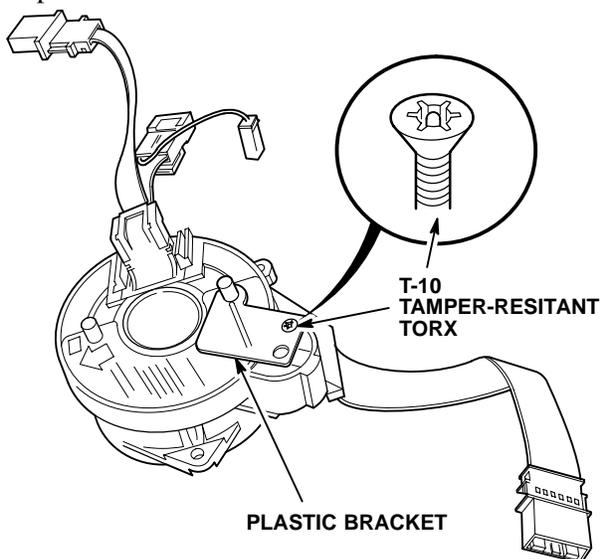
Replacement SRS cable reels are shipped with a plastic bracket attached that keeps the reel in the centered position. This bracket is held in place by a tamper-resistant Torx fastener. And believe us, it's "reel" resistant to tampering if you don't have a T-10 tamper-resistant Torx bit.

If you're interested in adding one of these bits to your tool collection, here are the tool numbers from some of the more common tool distributors:

Snap-on[TXXR-10	1/4, drive socket with bit
	TXXR-10-2A	1/4, bit only
Mac[T-10H	1/4, drive socket with bit
	T-10-HB	1/4, bit only
Matco	A10TP BI	1/4, bit only

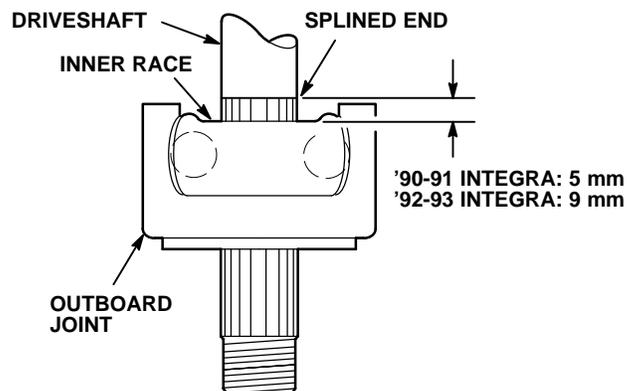
When replacing an outer CV joint on a '92-93 Integra, don't use the specs from the CV joint kit instructions. The instructions are correct for the '90-91 models, but the splined portion of the '92-93 driveshafts is longer. When you install the new outer CV joint on a '92-93 driveshaft, the distance from the end of the splines to the inner race of the joint should be 9 + 0.5 mm.

NOTE: Since the '90-91 driveshafts will supersede to the '92-93 type, it's best to measure the distance before you remove the old CV joint.

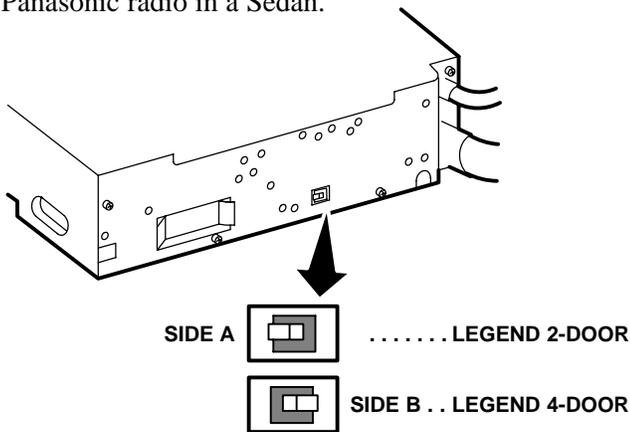
If you ever see an '86-90 Legend with an in-dash CD player that won't turn off when the ignition switch is turned off, make sure the mode switch on the back of the chassis is in the correct position. The mode switch allows the player to work in either a Sedan or Coupe, although their radios are made by different manufacturers. The switch should be set to "A" for the Alpine radio in a Coupe, or "B" for the Panasonic radio in a Sedan.

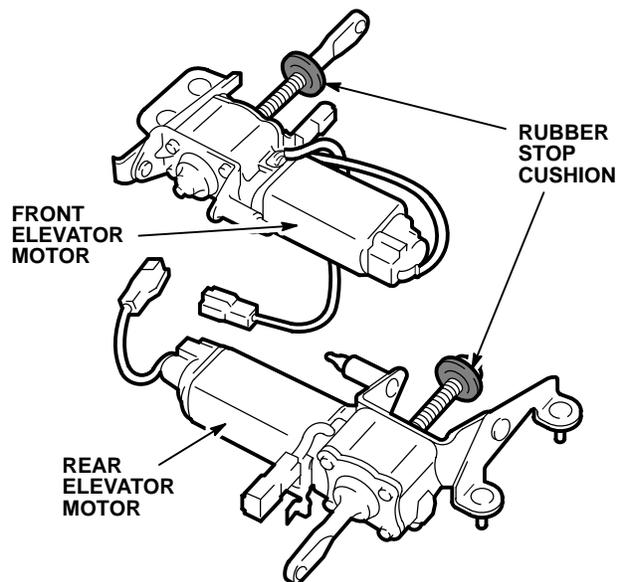
If you have a '93 Legend with seat rock, or a '91-92 Legend with repeat rock after performing S/B 92-017, don't replace both elevation motors automatically. Use the following procedure to see which motor (if either) is loose, or if the bushings are worn out.

1. Lower the seat all the way, then raise each end about one-half inch.
2. From under the rear of the seat cushion, locate the red rubber stop cushions on the front and rear motor lead screws.

3. With your hand on the rubber cushion, have an assistant sit in the seat and rock it back and forth. Don't let anyone move the seat with the motors while your hand is under there.
4. On a good motor, the rubber cushion will barely move in and out when the seat is rocked. If you feel a lot of movement on one motor, replace just that motor. If you feel little movement on both motors, check the linkage bushings.
