MODEL
LEGEND
VIGOR **NEW**

BULLETIN NO.
91-019

Passenger's Airbag Adjustment

(Supersedes 91-019, dated March 25, 1991)

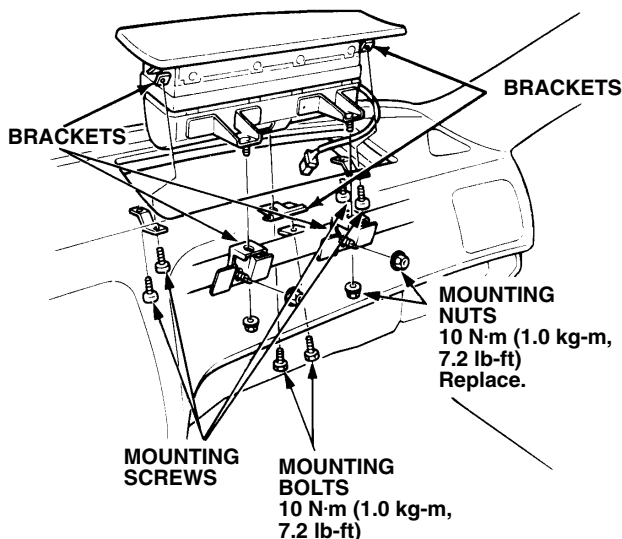
Legend:

The passenger's airbag top cover does not sit flush with the surrounding dashboard.

1. Check the alignment of the airbag top cover with the dashboard. Note where it sits higher or lower.
2. Remove the glove box as described in section 20 of the service manual.
3. Protect the dashboard around the airbag with duct tape.
4. Remove the passenger's airbag as described in section 23 of the service manual.
5. Move the mounting brackets to reposition the airbag as noted in step 1. The brackets are slotted to permit adjustment.

6. Reinstall the airbag and the glove box.
