BULLETIN NO.
93-015

Broken Seat Belt Tongue Stopper Button

(Supersedes 93-015, dated October 19, 1993)

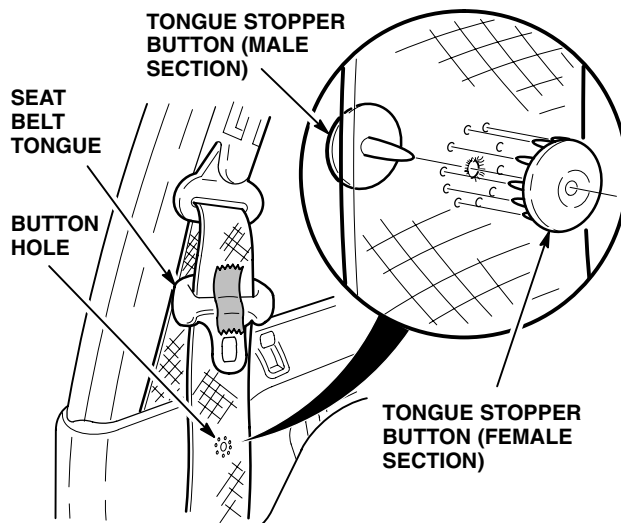
The seat belt tongue stopper button is broken, allowing the tongue to slide down to the floor.

1. Slide the seat belt tongue up the seat belt past the tongue stopper button hole. Temporarily secure the seat belt tongue to the belt fabric with masking tape.
2. Insert the male section of the button through the hole in the belt fabric. Align and install the female section of the stopper to the male section.
