YEAR  
1991

MODEL  
LEGEND COUPE

BULLETIN NO.  
91-044

## Replacement Of Rear Quarter Window Garnish Rubber

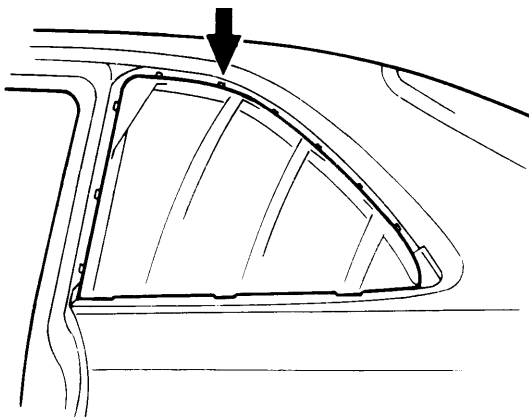
Damaged rubber on the quarter window garnish.

The window glass does not clear the quarter window garnish rubber.
