MODEL  
VIGOR  
LEGEND  
NSX

BULLETIN NO.  
92-039

## Rearview Mirror Reinstallation

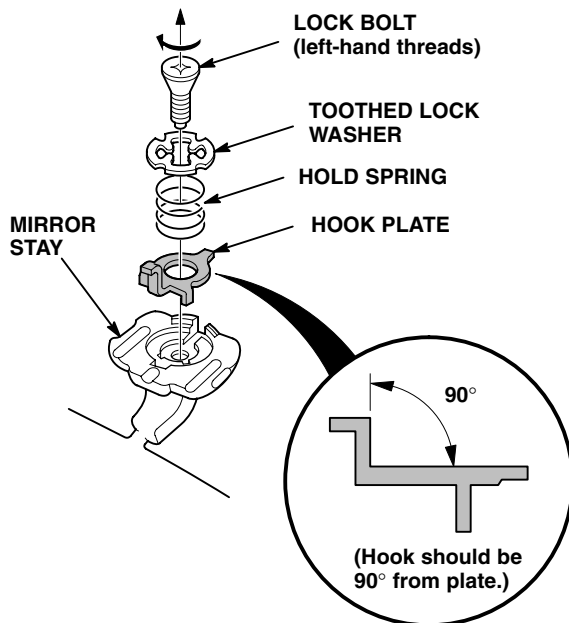
1. Remove the lock bolt from the mirror stay as described in the appropriate service manual.
2. Inspect the hook plate. If the hook plate is distorted, bend it to its original 90° position.

3. Inspect the lock bolt, the toothed washer, and the hold spring. Replace any parts that are missing, broken, or distorted (see PARTS INFORMATION).

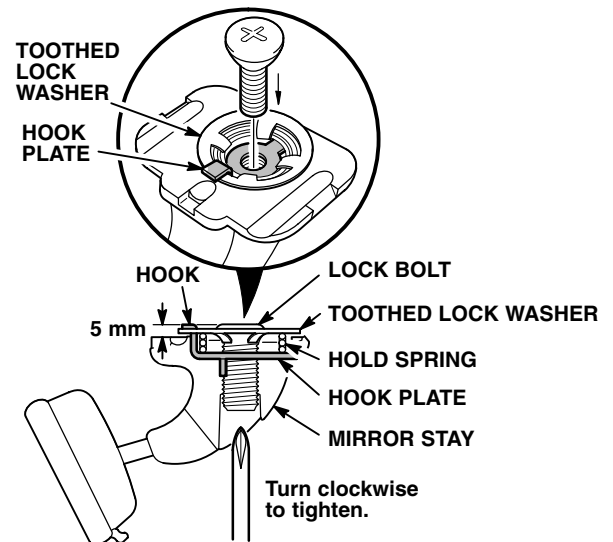
4. Loosely install the hook plate, hold spring and the toothed washer to the mirror stay using the lock bolt. Make sure the hook plate is over the top of the toothed washer. Thread in the lock bolt until the toothed washer is approximately 5 mm from the mirror stay.

5. Install the mirror on the windshield lug, and torque the lock bolt to 2.0–3.0 N·m (20–30 kg·m, 14–22 lb·ft).
