YEAR 1991 - 95 **NEW** MODEL LEGEND

BULLETIN NO. **91-045**

Erratic Remote Audio Control Operation

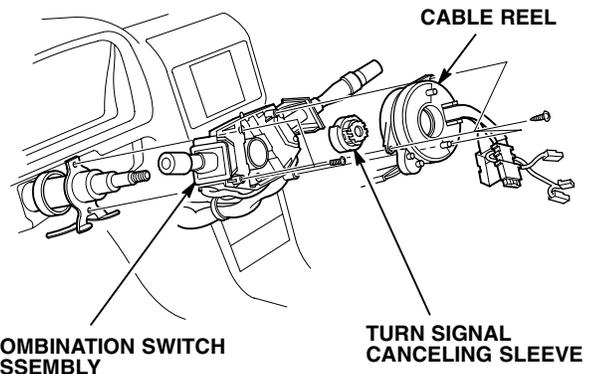
6. Remove three mounting screws, then remove the cable reel. Let the cable reel hang from the wire harness.

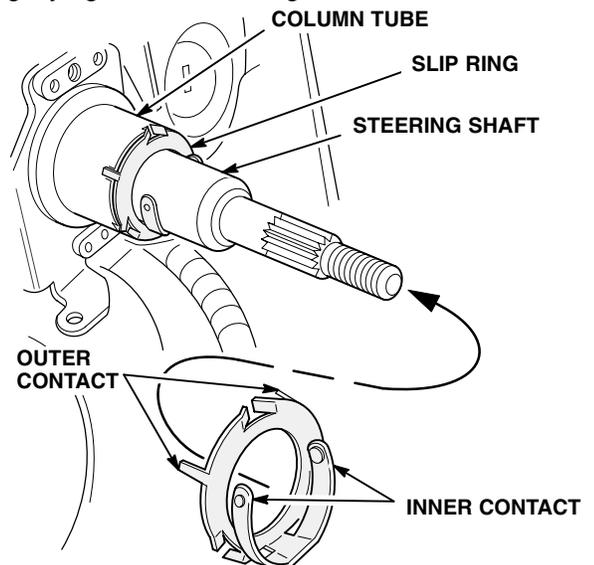
7. Remove the turn signal canceling sleeve.
8. Remove two mounting screws, then remove the combination switch assembly. For easier removal, angle it toward the passenger's side. Lay the assembly on the floor of the car, do not disconnect it from the wire harness.
9. Install the steering shaft slip ring as shown. The straight-cut edge of the slip ring should be on the bottom. Make sure the outer contacts fit tightly against the column tube and the inner contacts fit tightly against the steering shaft.

10. Install the combination switch assembly. Guide it in place carefully so you do not disturb the slip ring.
11. Install the canceling sleeve.
12. Install the cable reel assembly. Make sure the canceling sleeve and cable reel are engaged properly.
13. Install the upper and lower column covers.
14. *Center the cable reel* and install the steering wheel. Install the airbag.
15. Reconnect the battery negative cable. Enter the anti-theft code and set the preset buttons to the frequencies you recorded. Set the clock.
