Inner CV Joint Design Change

ACURA ServiceNews

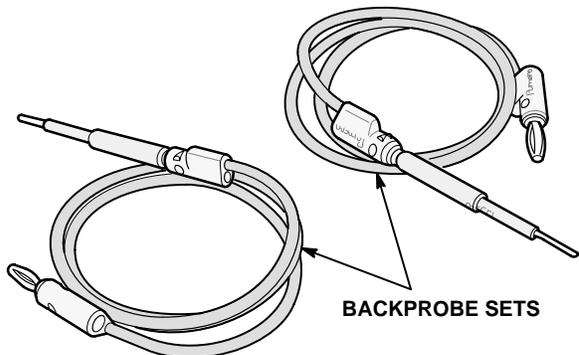
Our special wire harness backprobe sets make it quick and easy to take voltage measurements at wire connectors without damaging wires or connectors. Although two backprobe sets were sent to your dealership (two are required to take a voltage measurement), they're so useful and inexpensive, you should get a pair for yourself. Just order two, T/N 07SAZ-001000A. The current dealer cost for each set is only \$7.16.
