**ACURA** ServiceNews

BSN 16110 (9309)

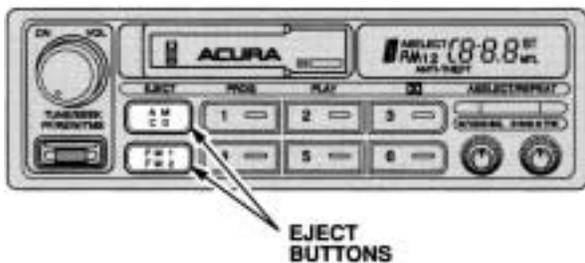
The owner's manual and the unit's faceplate both indicate that the AM/CD button is the cassette tape eject button. However, both the AM/CD button *and* the FM 1/FM 2 button will eject a tape. Why both? So you can select which audio function you want to return to after playing a tape.

If you eject the tape with the AM/CD button, the unit will return to the last function that was selected with that button (either AM or CD). Likewise, if you eject the tape with the FM 1/FM 2 button, the unit will return to the FM mode last selected.
