'91 Legend PDI Tips

ACURA ServiceNews

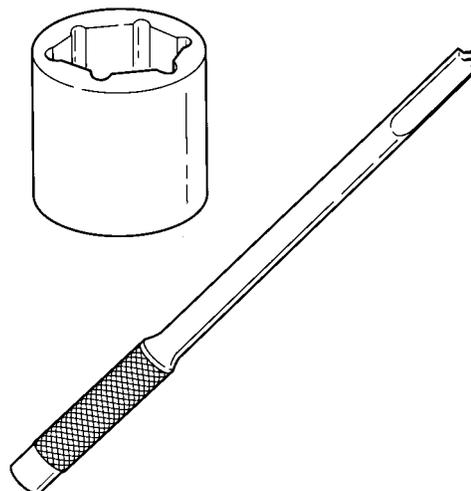
Snap-on Zero Clearance Socket Set

Snap-on Tools has recently released the Zero Clearance Socket Set, #2007TZC, especially designed for those easy-to-round-off "low-profile" trans and drive train locknuts. These impact sockets are designed with "zero clearance" (no countersink on the working end) and feature Flank Drive broaching for maximum flat-to-flat contact. The set includes: 17 mm and 22 mm 12-point sockets, and 18 mm, 19 mm, 21 mm, and 30 mm 6-point sockets. Also included is a unique shouldered staking punch with one flat side to hug the flat of the nut. Your local Snap-on representative can "set" you up.
