## Legend Interior Squeak and Rattles

### PROBABLE CAUSE AND CORRECTIVE ACTION

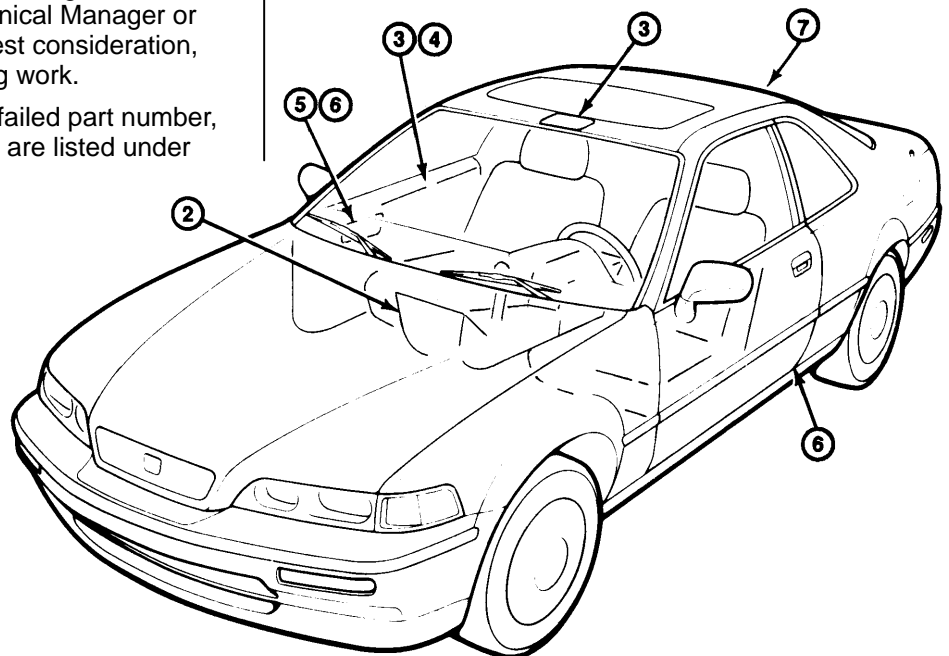
## CENTER CONSOLE

**Symptom:** Creak from the center console cover.

**Probable Cause:** The center console cover contacts the radio, the dash and the shift indicator garnish.

**Corrective Action:** Add or re-position the felt insulation.

1. Remove the center console cover. See section 20 of the service manual.

NOTE: Remove the two screws in the coin pocket.
