ACURA ServiceNews

BSN 20243 (9812)

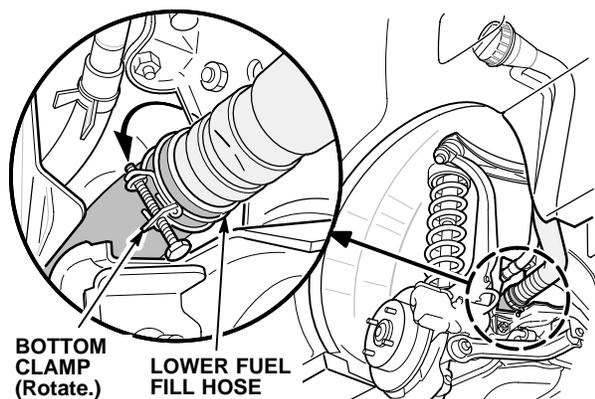
Rear Creak on '98 TLs

If a '98 3.2TL or 2.5TL creaks in the rear when entering a driveway, the noise may be caused by the fuel fill hose clamp rubbing against the rear beam. To stop the noise, remove the plastic cover at the lower fuel fill hose. Then loosen the bottom clamp on the hose, and rotate the clamp so it isn't touching anything. Finish up by retightening the clamp and reinstalling the plastic cover.

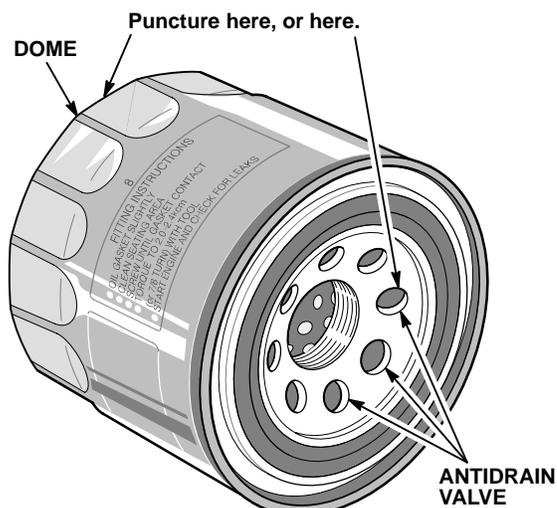
What to Do with Used Oil Filters

Since used oil is known to be a harmful pollutant, all the used oil coming through your shop must be recycled, even the residual oil inside oil filters. To drain the oil from a used filter, make a hole in the filter's dome or through its antidrain valve with a punch. The hole breaks the vacuum inside the filter and allows the trapped oil to drain out. It takes about 12 hours to completely drain an oil filter.

A quicker way to remove the oil is with an oil filter crusher. Crushers can be ordered through the Acura Tool and Equipment program.

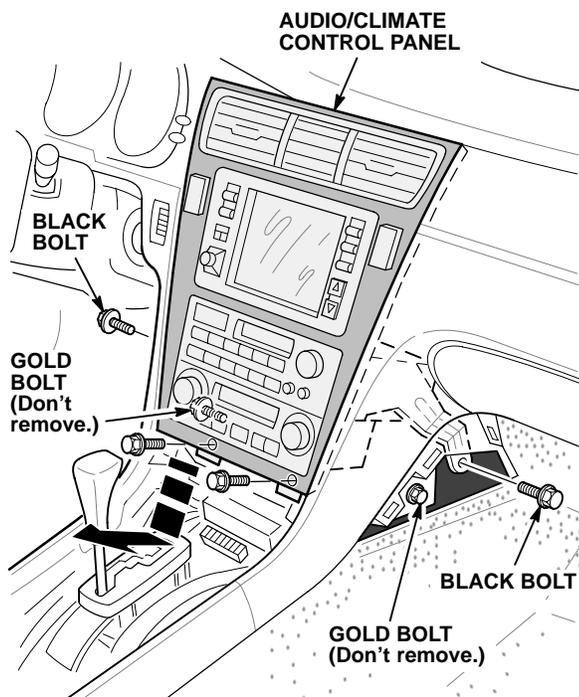
S/M Update: Audio/Climate Control Panel R&R

1. Carefully pull out the console lower carpet on the left side (three clips) and right side (four clips).
2. Pry up and remove the A/T gear position indicator trim (four clips, indicator light, and, if equipped, seat heater switch connectors). The heater connectors are driver's and passenger's seat-specific; don't mix them up.
3. Pry up (rear first) and lift out the console panel around the shift lever (four side clips, two front hooks, and one connector).
4. Remove the two bolts at the bottom of the audio/climate control panel.

5. Remove the panel's two side bolts (black) under the carpet on the left and right sides of the console. Don't remove the gold-colored bolts; they're part of the SRS unit bracket.
6. Carefully pull the panel down, and then out to remove it.

7. To reinstall the panel, push its lower half into place, then carefully push in the top until its hooks catch under the dashboard.
8. Reinstall the four bolts, and torque them to 7.2 lb-ft (9.8 NVm).
9. Reinstall the console panel, the A/T gear position indicator trim, and the carpet.
