BULLETIN NO.
92-018

Trunk Unit CD Changer Magazine Won't Eject

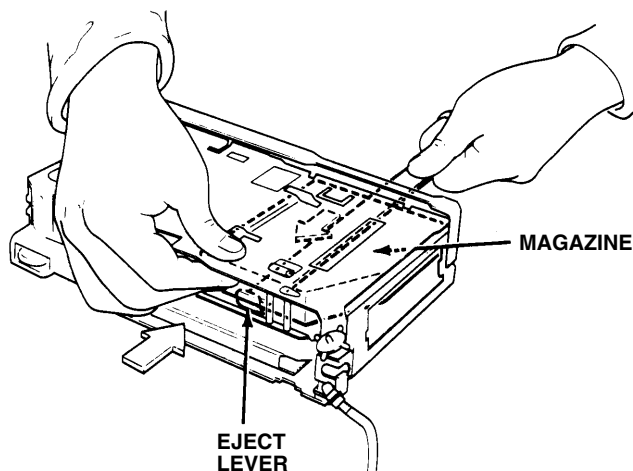
1. Remove the CD changer from the car.
2. Remove the side covers and the top case.
3. Slide a slim jim or a stainless steel ruler between the lower side of the CD magazine and the changer.
4. Push the eject lever toward the back of the unit while pushing the magazine out of the front opening.

5. Reassemble the CD changer.
6. Reinstall the changer in the car.
7. Replace the changer magazine with the new part.

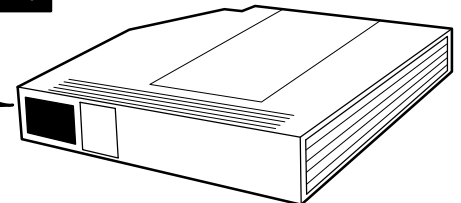
Improved changer magazines can be identified by this label.

Replace the magazine in the changer, and any other *Acura* magazines the customers may have, with the improved magazine. See PARTS INFORMATION.
